NAURU UTILITIES CORPORATION
Aiwo District, Republic of Nauru

Technical Evaluation and Assessment Study of NUC Power Generation and Distribution Systems

In support of the development of the Nauru Energy Road Map

Andrew D. Daka
5 June 2013

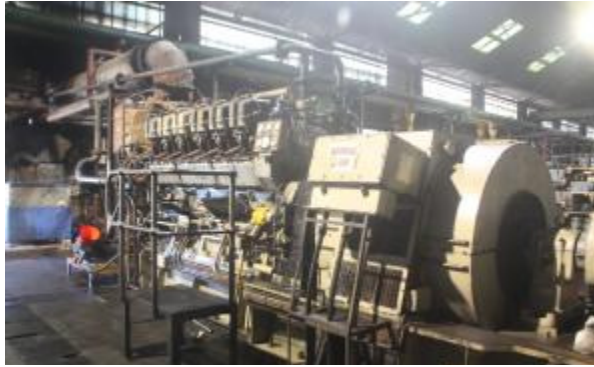
Figure 3: #1 Ruston RK270 Mark 1

This generator set was installed in 1989 and at present has 29,841 running hours on it. At the time of the mission the set was operating at 1 MW which is well below the optimum operating condition.

The engine is 189 hours short of its 30,000 hour overhaul and has been de-rated due to problems with recent peak pressure readings indicating that there is wear inside the cylinders which with the number of hours on the engine is to be expected. This engine should be overhauled as soon as possible.

The on engine fuel system has several leaks and some of the piping requires replacing.

The engine has been hard to start in the past due to bad air start piping, the piping requires replacing. The turbocharger outlet bend and the exhaust bellows both require replacing. The exhaust silencer outside of the station is showing signs of corrosion and should be changed to enable continued reliable operation.

The estimated cost of the major overhaul is AUD 250,000 and AUD200,000 for parts and labor respectively². Any major overhaul would take between 4– 6 weeks to complete depending on how it is arranged with a lead time of at least 8 weeks to procure and ship parts to Nauru.

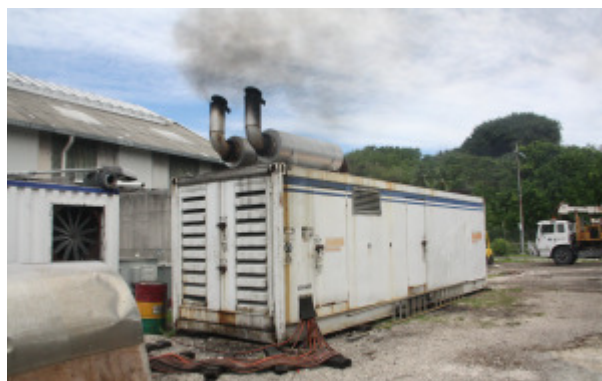
Figure 4: Cummins DTA5 Unit

The generator whilst rated at 1 MW is presently operated at 350 kW which is way below the optimum operating load of seventy to eighty (70 - 80) percent. Like all the Rustons, this set has not undergone any scheduled maintenance.

Extended running of any of the generator units at low loads would result in low fuel efficiency and accelerated engine wear.

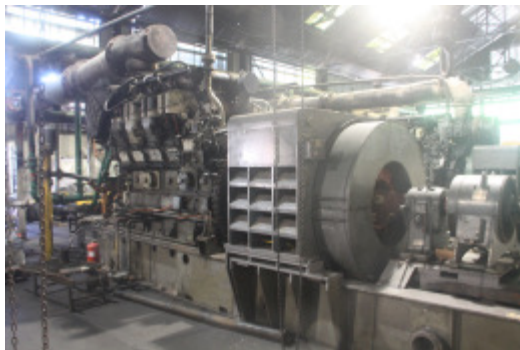
Figure 5: #5 Ruston 8RK3C

This set has been out of service since June 2012 with a faulty 1 MW alternator. It had 19,629 running hours on it when it went out of service. An attempt has been made by the previous Power Operations Manager to hook up a 2 MW alternator to the engine.

This action is ill advised, as the engine is likely to suffer mechanical damage due to the alternator being oversized.

The damaged stator of this alternator is presently sitting out in the open to the salty environment and to return this set to service would require fully stripping the stator coils and rewinding. Work will be also required to repair the old rotor to ensure that it is in serviceable condition. This can be only done overseas and most likely in Australia.

The on engine fuel system has several leaks and some of the piping requires replacing.

Best estimates put the cost of repairing the alternator at AUD250,000 with the rotor having to be shipped overseas and the work taking at least six to eight weeks to complete.

The estimated cost of the major overhaul is AUD 450,000 for parts and labor and overhaul taking 4 –6 weeks and a lead time of about 8 weeks as is the case for the #1 Ruston.

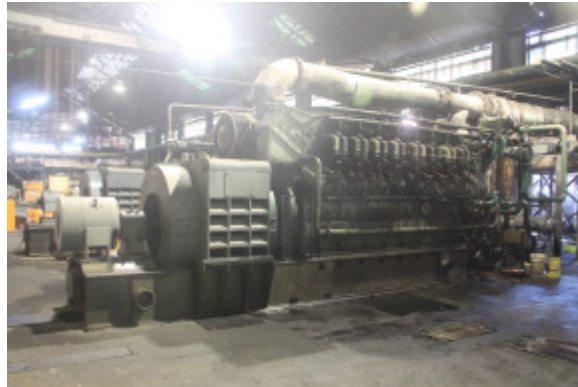
Figure 6: #6 Ruston RK3C

Whilst this generator is operational, observed during the mission that this needs urgent attention to address oil leaks that were very evident. The on fuel system also has several leaks some of the piping requires replacing.

Recent peak pressure readings are indicating that there is wear inside cylinders which with the number of on the engine is to be expected and engine will require a major overhaul before the end of this year depending on the number of hours that it is required to operate.

The charge air system is leaking and requires new rubber sections to be fitted. The engine has been hard to start in the past. Some of this is likely to be caused by bad cylinder compression along with some faults with the air start distributor.

The exhaust system and bellows both require work carried out on them and possibly replacement of some of the components including the silencer.

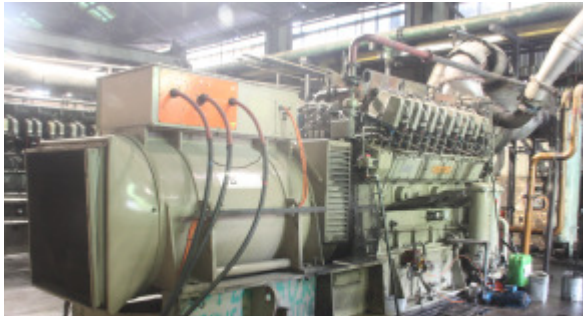
Figure 7: #7 Ruston RK270 Mark II

This set is generally in better condition appearance wise but recent peak pressure readings are indicating that there is wear inside the cylinders which with the amount of hours on the engine is to be expected.

The on engine fuel system has several leaks with the leaks from the fuel injection pumps that were not properly serviced appearing to be the major source of the fuel leaking.

Utilities did not purchase the correct exhaust silencer for financial reasons and therefore the silencer that had been fitted to the caterpillar engine that was in the #7 position previously was used. Readings taken at the time found that the backpressure on the turbocharger was well outside the recommended levels and the silencer was found to be too small for the application.

The charge air inlet pipe had suffering some cracking; this pipe was manufactured on the island from the original material that was installed on the engine at its former power station. The original installation of the engine was supposed to have the charge air pipe come straight out of the engine but the pipe had to bent to allow access for the forklift in front of the engine and as a result of the bends the charge air piping is cracking due to vibration caused by not properly supporting the pipes.

The turbocharger outlet bend requires replacing along with the bellows and the silencer.

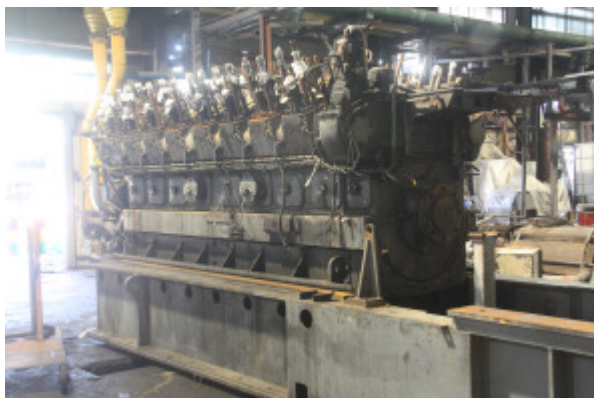
Figure 8: Recently bought Ruston Unit

Based on information obtained from MAN Diesel, the Ruston unit was first installed in a mine in Australia in 1973 before being bought by Anguilla Electricity in the Caribbean and eventually finding its way to Nauru. This has been moved into the generator bay and currently partially stripped with the alternator yet to be mounted. The engine is missing essential parts such as the radiators and piping for fuel, oil and water.

At the time of the mission, NUC had invited personnel from MAN Diesel to assess the engine and determine the work required to put the engine into service. In my discussions with the MAN Diesel officer, it would take a complete rebuild of the engine before it can be put back in service. Furthermore, the

alternator needs to have the windings checked and stripped, rewound if found to be faulty to ensure that there are no future problems with it. It must be noted that the alternator is presently sitting in the open without covers or heating.

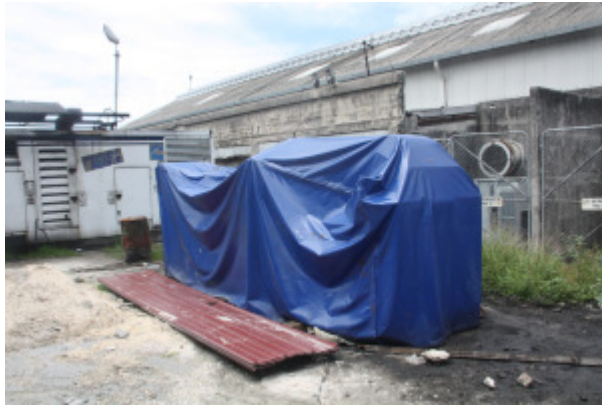
Figure 9: 'New' Caterpillar Unit

The second unit is a high speed Caterpillar unit which had been previously used as a standby set for one of the Australian Federal Government offices. This unit is located outside the powerhouse waiting for the completion of the generator shed before it is moved into position in the generator shed.

Like the Ruston, it is missing some major components such as the exhaust stack, the ancillary panels and switchboard.

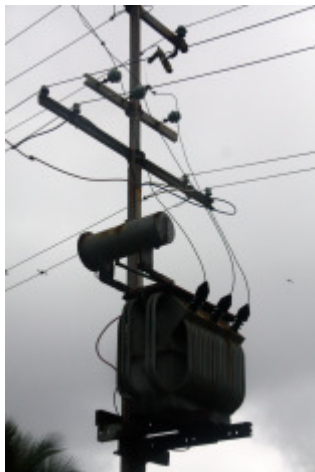
The overhead transmission/distribution network has deteriorated badly particularly on the Ringmain North feeder, which is on the windward side of the island. There is heavy corrosion affecting all the poles, transformer, line fittings and conductors

It was noted during inspection of the feeders that most of the distribution line fuses were no longer functioning. This has resulted in non-discrimination of faults and in quite a high number of cases resulting in blackouts in the system.

On the positive side, NUC has recently commenced a program of replacing the steel poles with wooden ones as well as the replacement of faulty line fuses to reduce the extended outages. A number of distribution transformers need to be replaced immediately as oil is leaking badly from the tanks.
