# Rapid Assessment of Shoreline Erosion in Kemur Beab, Ngermeaus and Ngkesill Islands, Rock Islands, Southern Lagoon, Palau

## SOPAC Technical Assessment Report PR112

**SOPAC Technical Assessment Report PR112**

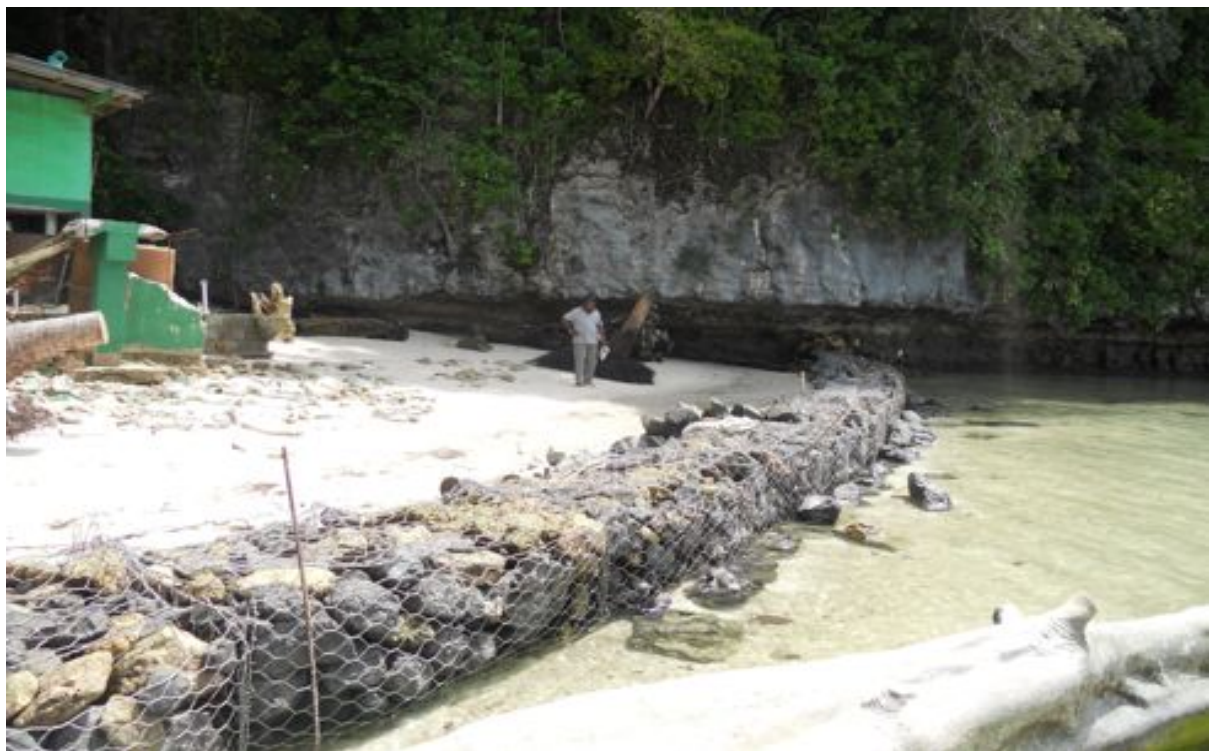
The eastern shore of Kemur Beab Beach has eroded significantly and a compost toilet facility has been undermined and lost (see images below). Likewise, picnic tables and shade facilities nearer the southern shoreline of the beach have also been lost. These losses are not trivial for the Rock Islands Authorities who are now working to ensure adequate facilities continue to be provided for visitor's needs and thus maintain tourism revenues. Also due to the costs and logistic challenges of transporting and building facilities in the Rock Islands it is not surprising that Koror State Government has taken the decision to armour the eastern shore with rock filled gabion baskets. The alignment of the wall is thought to be roughly equivalent to the position of the shore as perceived at the time of building the toilet facilities. The wall is intended to protect the remaining compost toilet and presumably provide confidence to reinstate the second unit.

Protective gabion basket wall and remains of one of two compost toilet facilities to the left. The wall approximates the former berm position.

The gabion wall design is simply two vertical steps each about 2ft high with the upper set back about 2ft. This more or less vertical hard surface replaces what was a very shallow sloped soft beach and it follows that the ability of sand to establish and deposit at the foot of the new wall may be prevented as vertical structures tend to reflect wave energy pushing sand away. If the wall remains the preferred option by the local authorities, it is recommended that it be constructed with a slope approximating that of the natural shore as this will have far higher chance of allowing sand to naturally accrete and bury the wall over time. A correctly sloped wall is also less likely to disturb nearby beach areas, whereas vertical walls can cause downstream erosion.

4. Consider adjusting the present plan for shoreline armouring. This structure has only been partially constructed and could still easily be removed to allow natural shoreline process to reinstate the beach. Obviously this would be contingent on relocation of the compost toilet and picnic facilities.

- a. If the decision is to keep the gabion wall, consider the use of dredged lagoon sands for back filling. Mining the newly accreted western beach in not recommended and

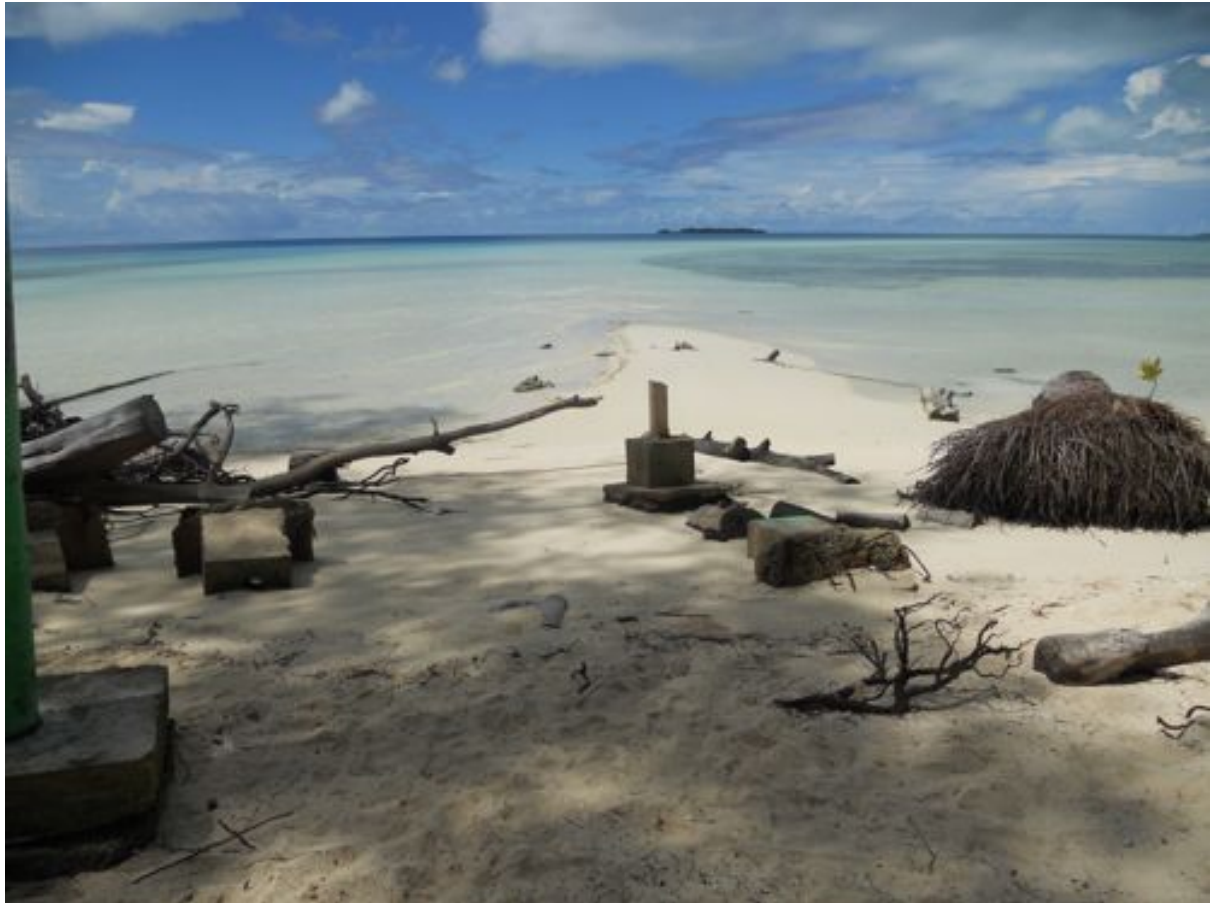
Footings from the former shade and picnic table facilities. Note the reforming raised southern sand spit and larger sub-tidal feature stretching towards the west (right).

3. Near-shore picnic table and shade facilities could be designed to be easily re-locatable. This would allow rangers to move these if seasonal shoreline shifts start to threaten the position of the structures. It will be important to ensure appropriately designed fastenings and footings are devised to avoid wind damage etc.

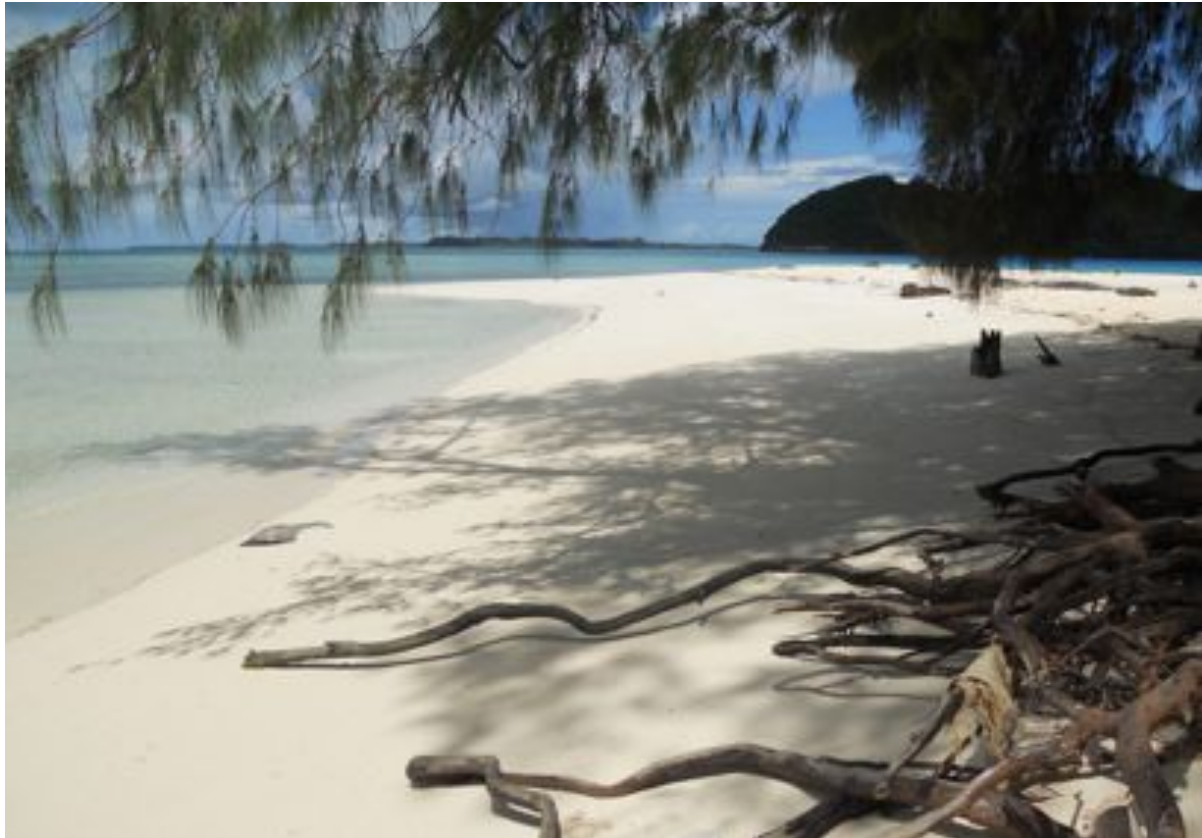
The newly accreted western shore area at Kemur Beab Beach, tourist activities have already naturally followed this shoreline trend away from the eroded areas. This suggests the natural seasonal and event driven cycling of the shoreline position does not necessary impact tourist perceptions and needs, they are happy to use this new beach area.

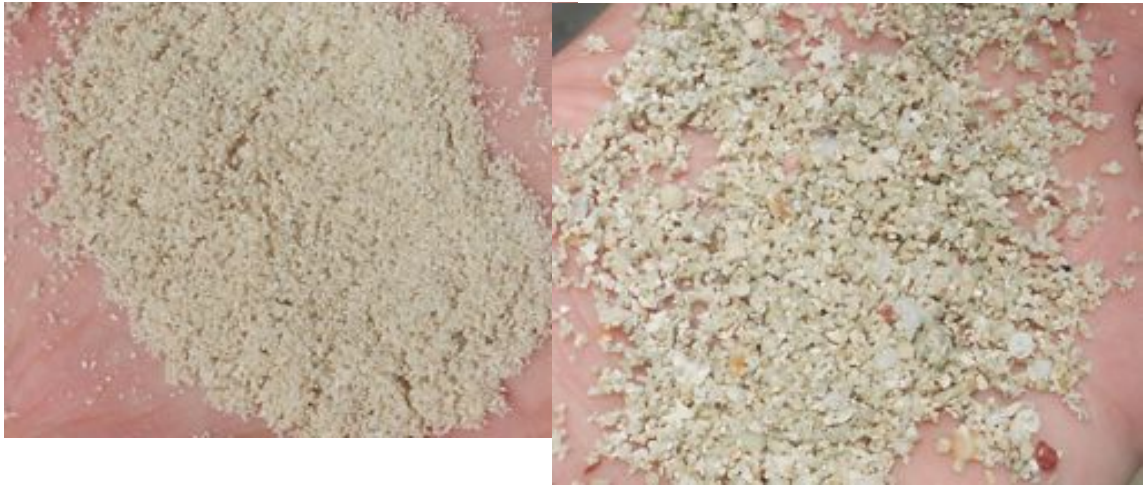
Sand from the accreting western shore (left) and erosive eastern shore (right). Note grain size of the newly accreted beach was fine  $<0.25\text{mm}$  and generally very well sorted, grain size on the erosive shore was generally larger  $>1.5\text{mm}$  and not so well sorted.

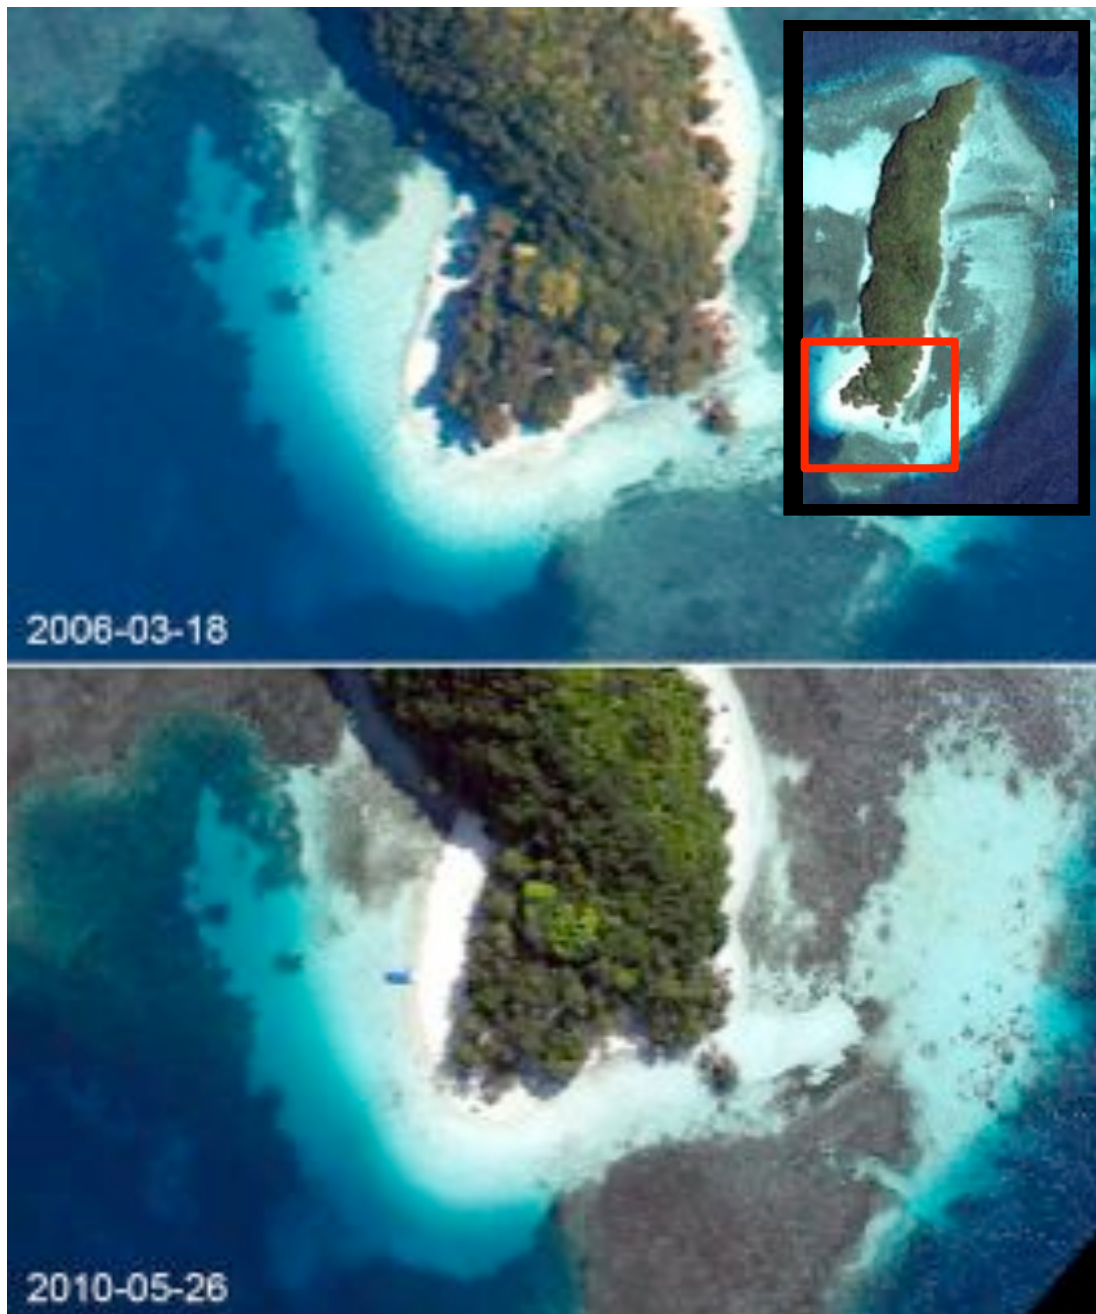
Two images of Ngermeaus Island and tourist beach area in the south. The change in the position of the toe of the beach in the east is easily seen (it's moved landward in 2010) and the western beach (left hand side) has clearly accreted westwards (images sourced from Colin, 2011).

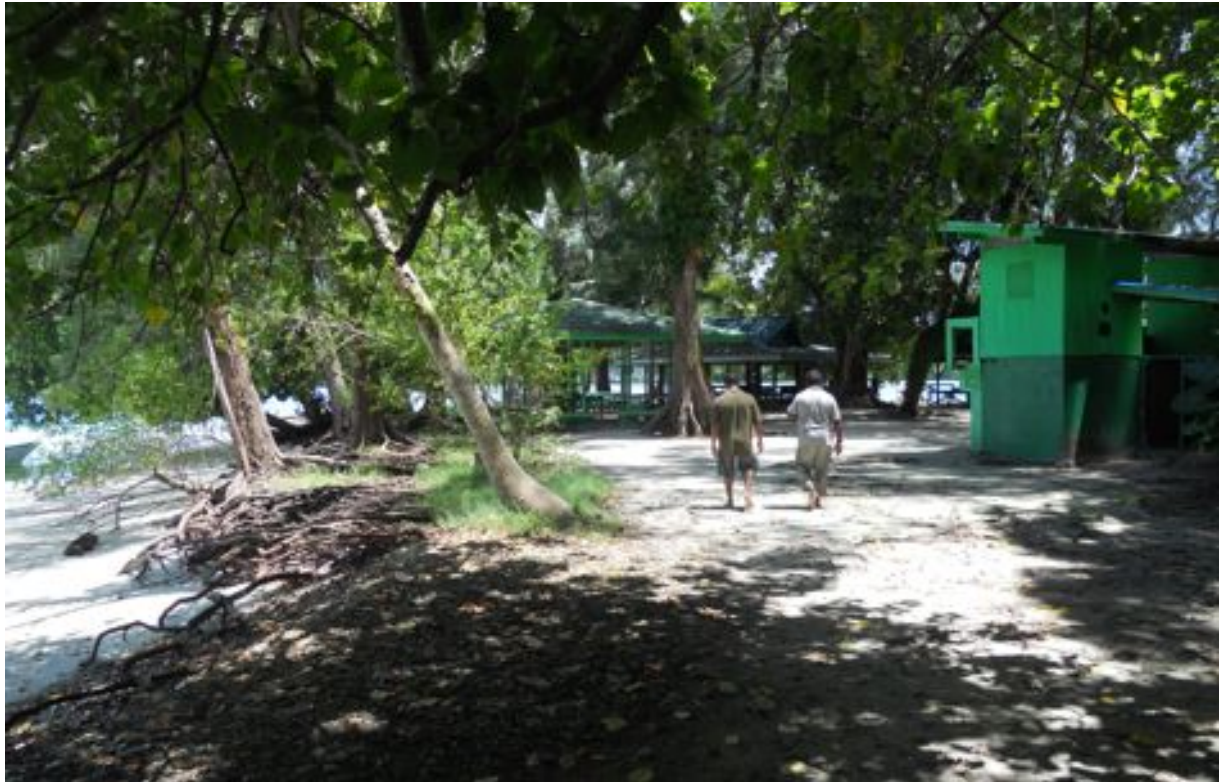
Fortunately at the time of writing infrastructure at Ngermeaus Beach had not been damaged however a number of fairly large trees have been lost and the photo below shows the close proximity of the compost toilet and picnic facilities to the erosive shore. At this stage no engineering response has been implemented but it was understood that depending on the success or otherwise of the hard structures being built in Kemur Beab such measures may also be implemented in Ngermeaus Beach as well to prevent what is perceived as loss of land and possible risk to infrastructure. The consideration of alternative management and response action on Ngermeaus Beach is recommended before any hard engineering or more structures such as toilets are considered. The reservations shared already about placement of buildings and use of hard shoreline protection in Kemur Beab Beach are identical on Ngermeaus Beach.

Eastern end of Ngermeaus Beach showing undercut tree roots and proximity of the composting toilet block and in the background a picnic shelter which is within a few feet of the shoreline. Again, the design of the toilet block necessitates a sunny position and any retrofitting techniques applied in Kemur Beab could equally assist to develop a strategy to move these facilities well inland.

2. Toilet amenities; investigate the potential to retrofit these with active ventilation (possibly solar) this would provide greater options in terms of their location.

- a. Re-location to safer inner areas of the beach being preferable.
3. Near-shore picnic table and shade facilities could be designed to be easily re-locatable. This would allow rangers to move these if seasonal shoreline shifts start to threaten the position of the structures. It will be important to ensure appropriately designed fastenings and footings are devised to avoid wind damage, etc.

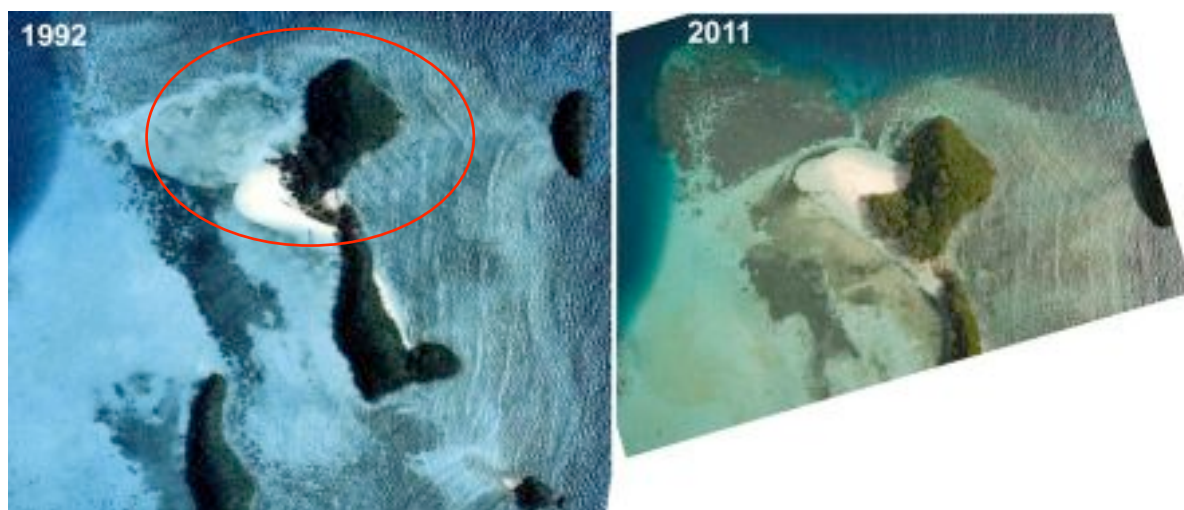
Two images of Ngakesill Island (red circle) from 1992 and 2011 (sourced from Colin, 2011). The Ngakesill Beach area appears to be fed from sand which moves from around the northern shore as well as via a narrow low-laying gap between the islands. The shift or redistribution of sand between 1992 and 2011 shows clearly the removal of sand from the south-eastern shore and accumulation on the north-western shore (see also July 2012 photos below).

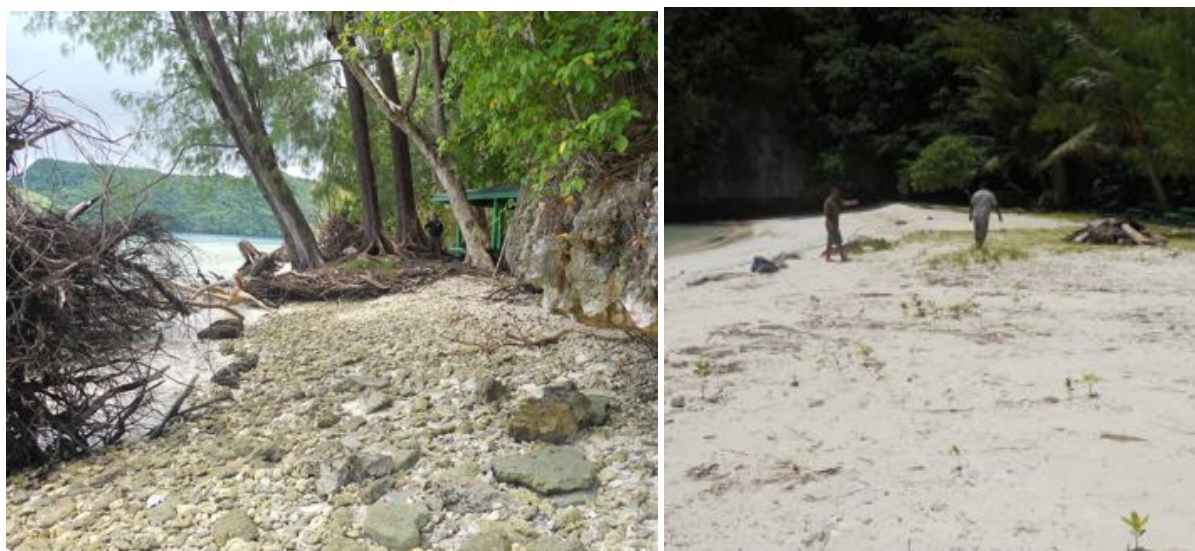
Contrasting views of Ngakesill Beach area, to the left this area at the south-eastern end of the beach is now composed of exposed rubble and was several years earlier a sandy beach, note also fallen trees and proximity of the picnic shelter in the background. On the right is the north-western end of Ngakesill Beach and it clearly shows rapid accretion. The green picnic tables to the right in the background of the image were formally situated just behind the beach berm (top of the beach) they are now many yards behind the berm.

2. Near-shore picnic table and shade facilities could be designed to be easily re-locatable. This would allow rangers to move these if seasonal shoreline shifts start to threaten the position of the structures. It will be important to ensure appropriately designed fastenings and footings are devised to avoid wind damage etc.

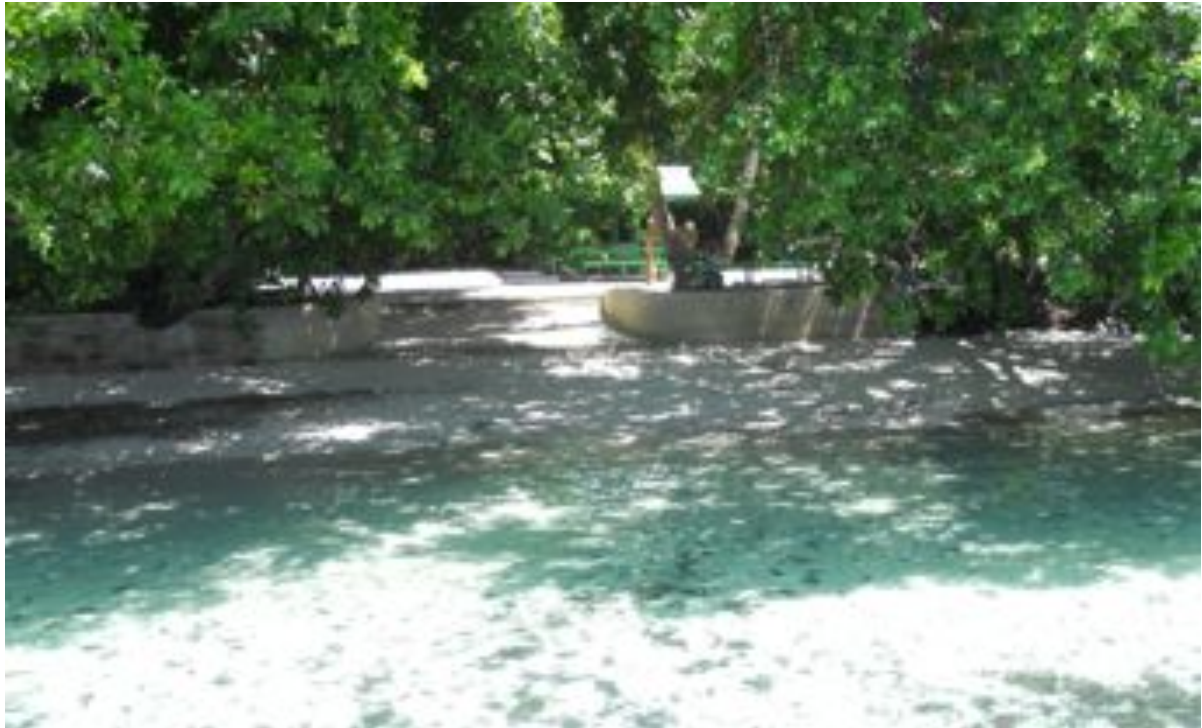
Site 4. Located near Ngermeaus Beach with an easterly aspect this north / south running beach has been subject to hard vertical seawall construction. There was low sand accumulation in front of the wall and exposed beach rock can be seen to the left. Vertical walls tend to reflect wave energy and frequently push sand away rather than allowing it to deposit on the shore.

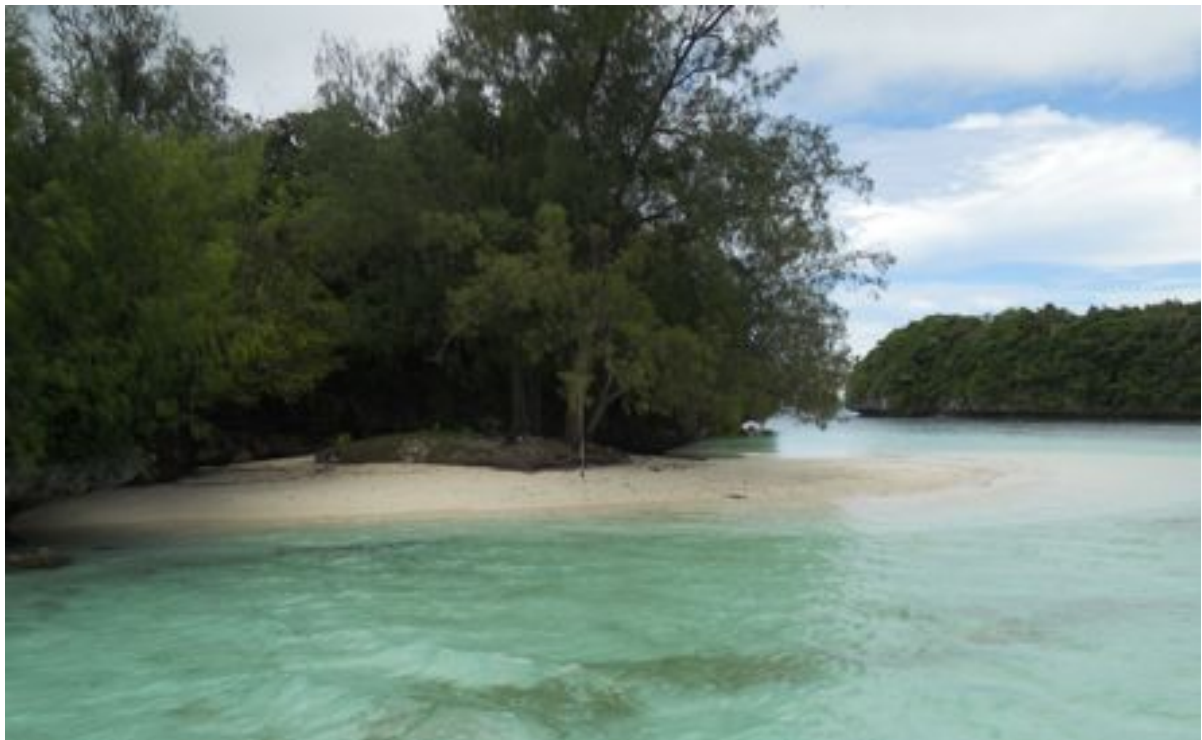
Site 5. Small pocket beach near Ngakesill has lost elevation and sand appears to have been redistributed into deeper water towards the west (right in the picture). Whilst this is a similar pattern to the study sites it must also be recognised that such a small “two-tree” islet simply cannot sustain a large amount of human traffic. These are very fragile environments and foot traffic alone could easily critically destabilise such a beach. This highlights the importance of the strategic closure and reopening of such beach areas to allow time for recovery.

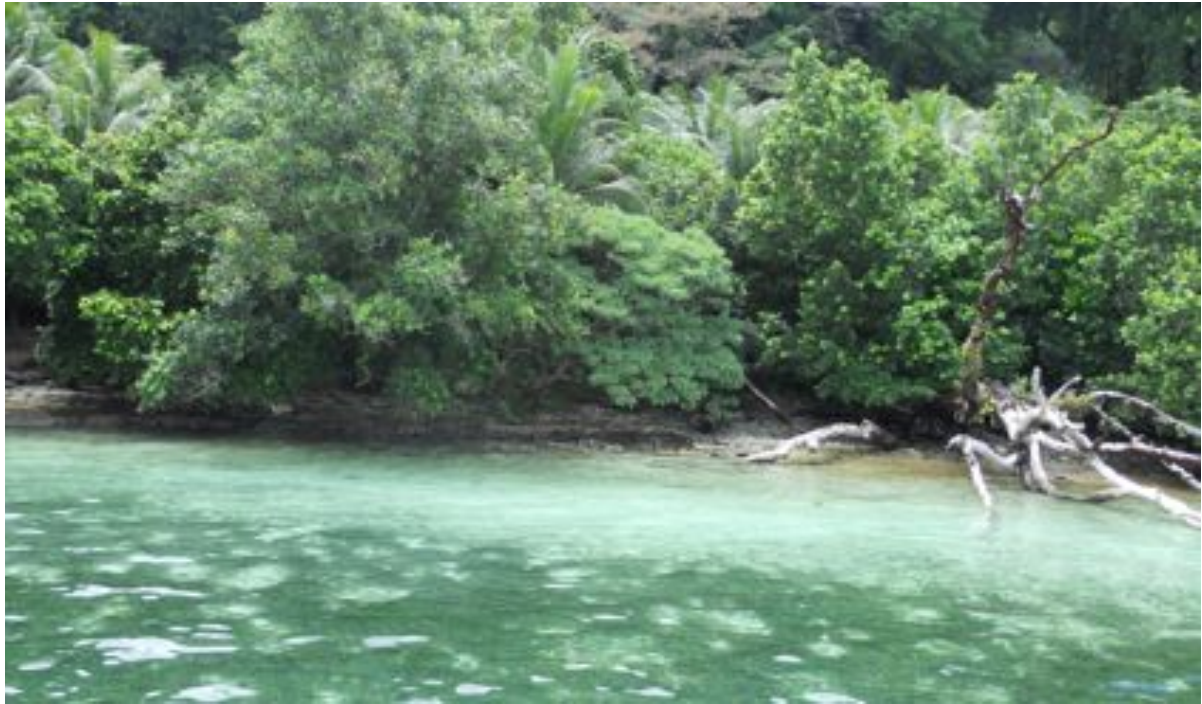
Site 6. This beach area closer to Koror is several hundred yards long and faces east and is orientated approximately north / south. The beach is closed to tourists but is a favourite picnic location for local families, however it has become so eroded that only coral rubble and beach rock remains over much of its length. At the southern end some experimental nourishment has been undertaken using lagoon basin dredged sand. Interestingly this was seen as a failure by the State Authorities because the sand has migrated southwards into inaccessible sub-tidal areas. Nonetheless, a soft beach still exists at the southern end of the beach and it seems that the concept of nourishment has perhaps been misunderstood. Nourishment generally requires a continual effort and sustained strategic replenishment in order to retain a sandy beach.

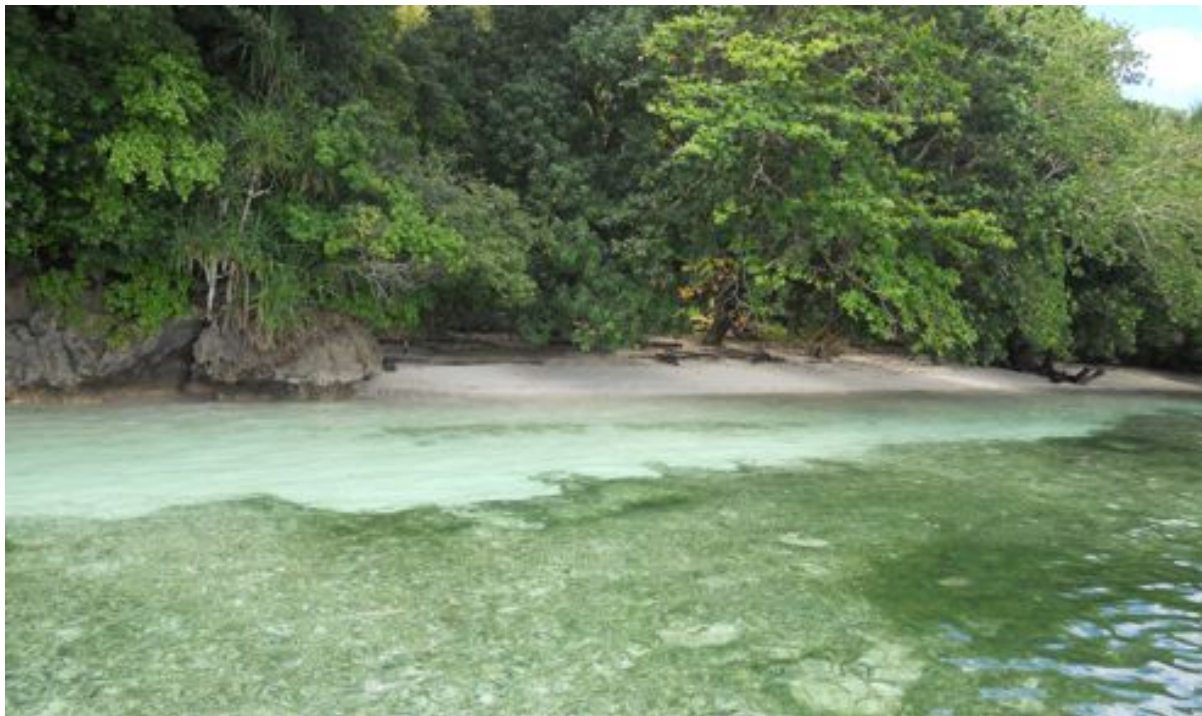
Site 7. This beach lays directly north of the previous location and shares the same orientation and exposure, however it is clearly a far more stable system in comparison and remains sand covered. The precise reason these two locations are so different is unknown but it does appear that the second beach is not so heavily used for recreation as a private dwelling is located here. It is possible that heavy use has played some part in the erosion of the previous beach but such questions deserve more thorough investigation.
