NAURU UTILITIES CORPORATION
Aiwo District, Republic of Nauru

Technical Evaluation and Assessment Study of NUC Power Generation and Distribution Systems

In support of the development of the Nauru Energy Road Map

Andrew D. Daka
5 June 2013

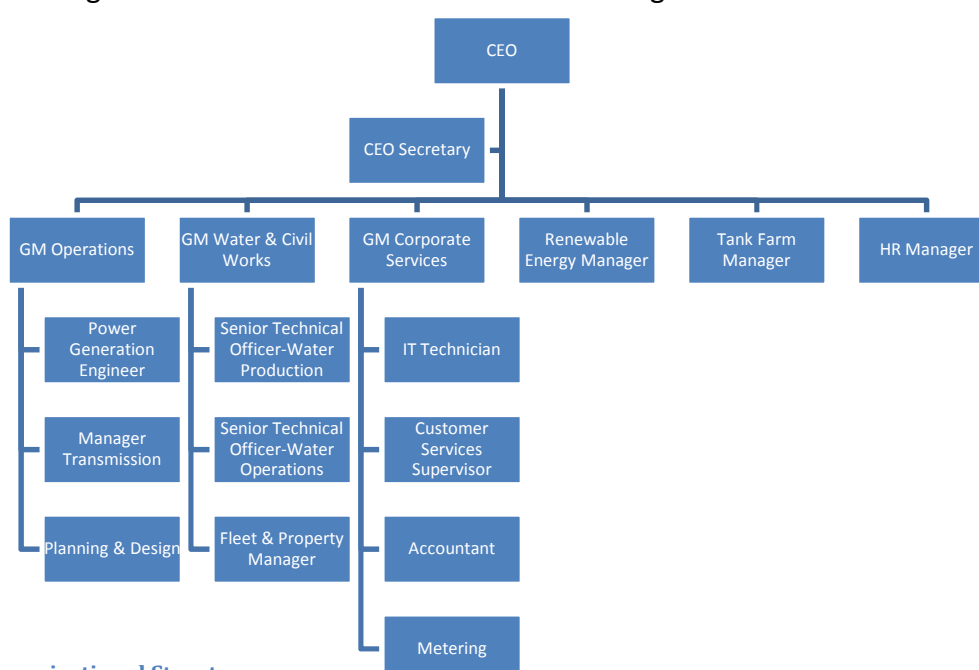
Figure 1: NUC Organizational Structure

Whilst the arrangement may be streamlined, it does not provide a buffer between the management of the operations of the Utility and the utility being used as a political tool. The direction of the utility would be very much exposed to change in governments which could lead to detrimental effects for the people of Nauru.

Whilst NUC presently has an Advisory Committee which is selected by the Minister responsible for NUC, this Committee does not have any decision making powers. Its recommendations to the Minister may or may not be considered.
