Woja Causeway Project: Detailed Design and Monitoring Plan

This report provides the second output for SPC contract CC/13/357, which has been developed to provide detailed engineering design and a monitoring plan for coastal protection works for Woja Island, Ailinglaplap Atoll, in the Republic of the Marshall Islands following the coastal processes and feasibility report. It is recommended that the feasibility study is read prior to reading this document if an in depth understanding of the design process is required. Specifically, the second stage of the project included:

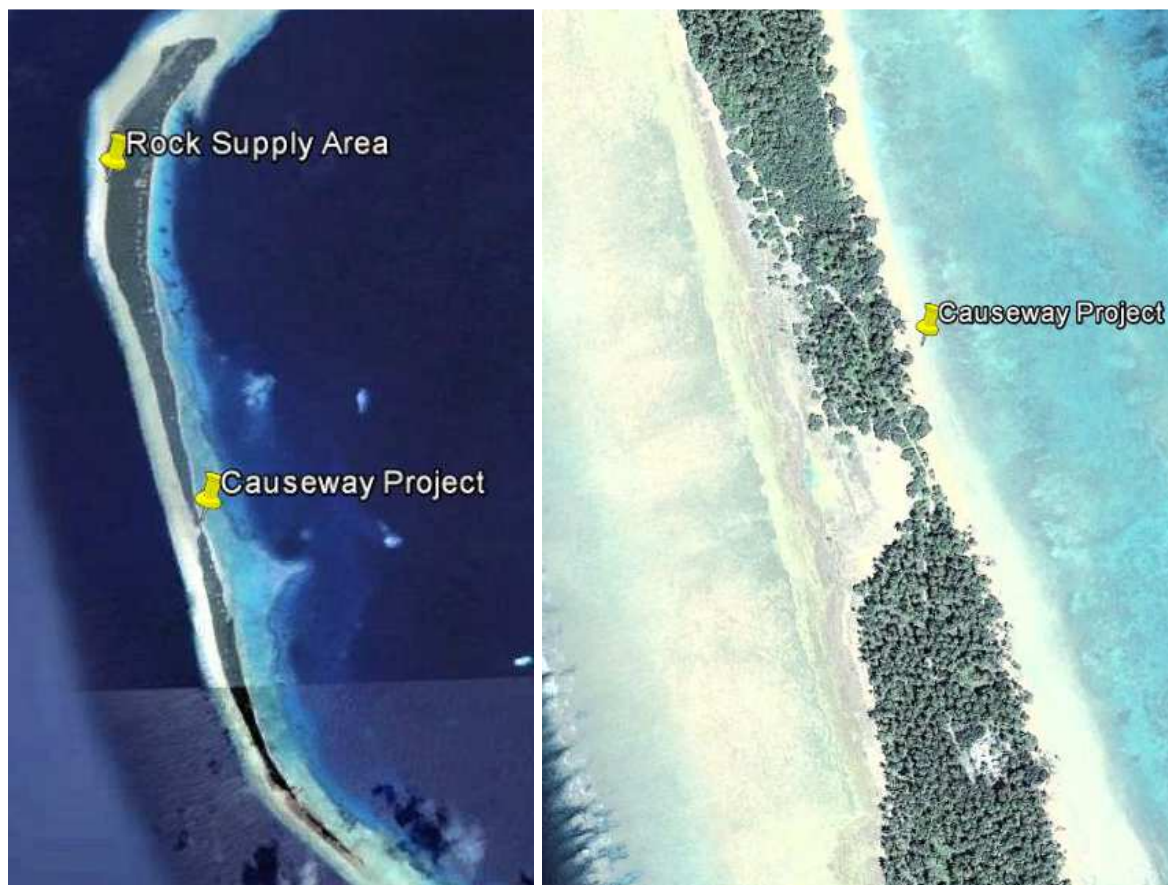
Figure 2.1 shows satellite images of the project site and the potential source for construction materials some 4 km to the north of the site.

Figure 2.1. Location of the project site and potential construction material area. (Source: Google Earth, 2014).

Due to the isolation of the atoll, part of the site visit undertaken for the feasibility study was directed to identifying suitable construction material on the island, mainly large rocks for armouring the causeway. Suitably sized rock was identified on the northwestern coast of the island (Figure 2.1). This location includes an extensive area of large rocks (many >1.0 m in diameter) which were considered suitable for construction units – calculation of maximum wave heights and consequent rock sizes required for armouring are presented in the feasibility study (Mead *et al.*, 2014).

The source of construction rocks (Figure 2.1) is some 4 km north of the project site, and access is available via a coastal road adjacent to the school. There are extensive volumes of rocks that are located on a flat reef platform, which make access to them relatively easy during lower tidal phases (Figure 2.10). These rocks have been broken off the outer edge of the platform reef during large wave events and thrown up onto the flats. Over time they are worked shoreward and slowly reduced to smaller and smaller boulders. An additional advantage of this source site is the abundance of smaller boulders armouring the beach (Figure 2.10), i.e. removal of a relatively low number of large rocks on the platform reef is unlikely to have any

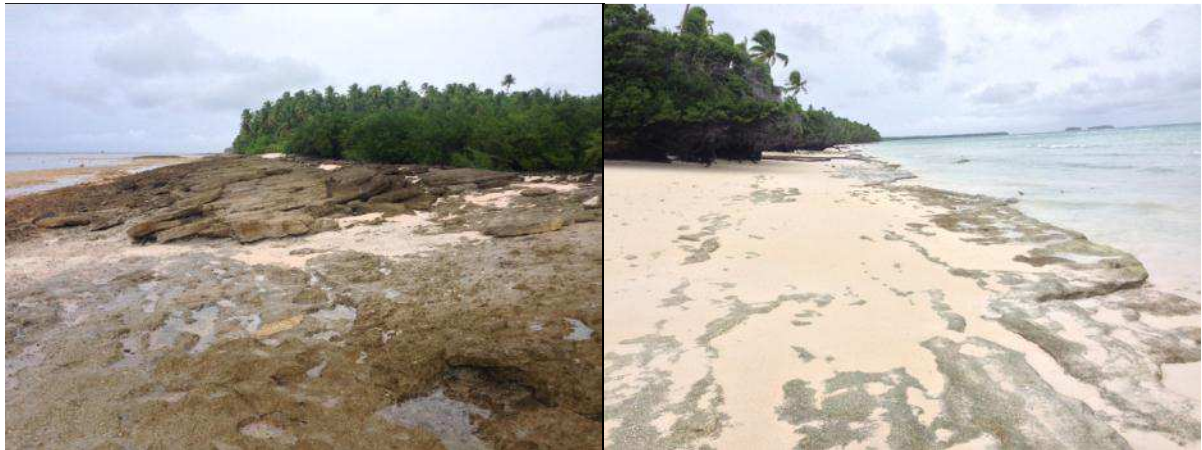
The project site is some 400 m from north to south, with a low beachrock reef on the western open ocean side and low limestone rock flats (near the low tide level) below a sandy beach on the eastern lagoon side (Figure 2.2). The area of low and friable beachrock reef on the western side of the site is the only part of the island's surrounding reef flat that is comprised of this type of rock and is distinctly lower than the reef platforms to the north and south of the area – the length of beachrock on the western reef flat adjacent to the causeway area is clearly visible in Figure 2.1.

Figure 2.2. Left: The low-crested, friable, beach rock reef on the western side of the project site. Right: the flat limestone reef flat near low tide on the eastern lagoon side of the project site.

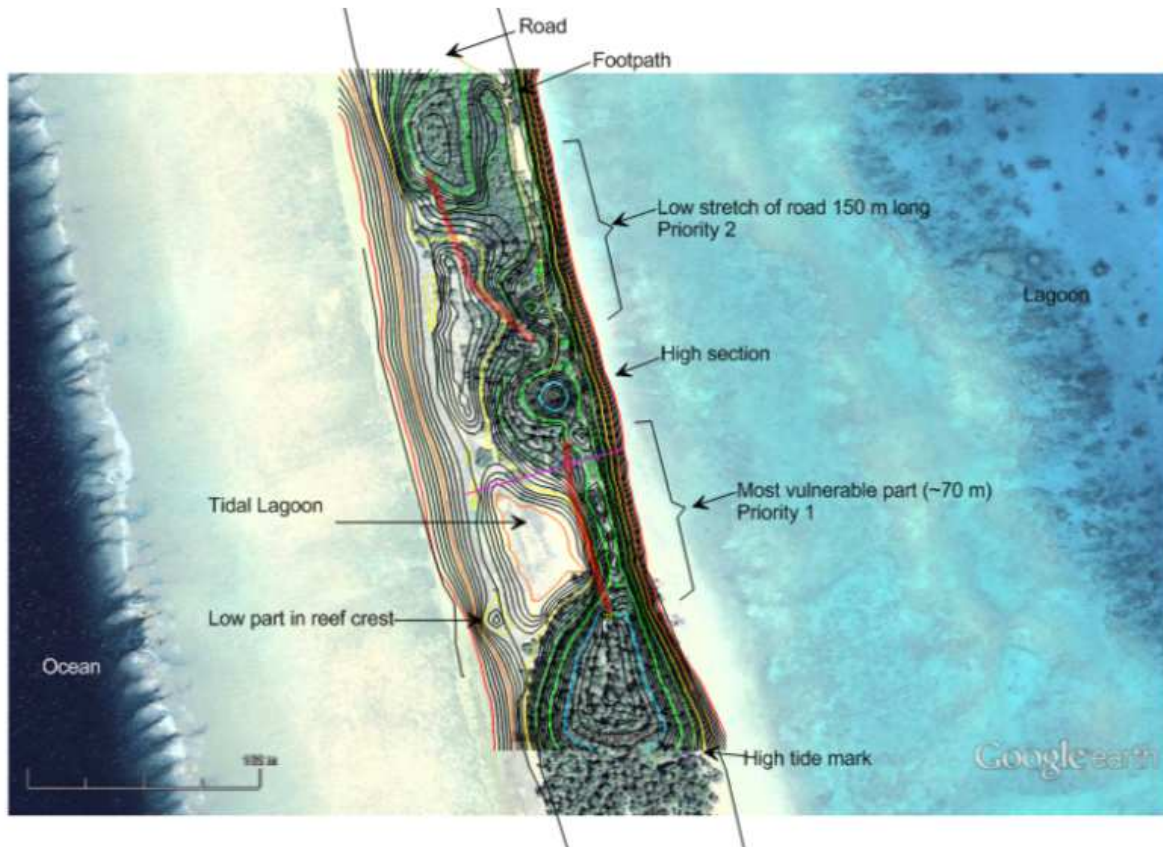
There are two parts of the causeway that require protection and elevation to allow all weather access (presented in Figure 2.3):

1. The southern part is some 70 m long and located close to the eroding eastern lagoon side of the island – this site is considered the most vulnerable, and is located on a strip of land only 10 m wide between the lagoon-side beach and the small tidal lagoon inside the beach reef on the western side (Figure 2.4). This stretch is considered the first priority for the project.
2. The northern part is separated by a ~90 m long high area of the road (it is over 3 m above chart datum along some of this stretch), and is comprised of a low area of road some 150 m long that is flooded 1-2 hours either side of low-tide (Figure 2.5). However, while access is restricted during higher tidal levels, this section of the road is not vulnerable to erosion or wave attack. Thus, this section is considered the second priority for the project.

Figure 2.3. The project site is divided into 3 distinct areas – the first priority most vulnerable 70 m length of road in the south; the high central section of the site, and the second priority 150 m low stretch of road to the north.

On the southern part of the project site, at the Priority 1 site, the high tide fills a tidal lagoon know as Diamond Kan (Figure 2.3), which results in this stretch of the island being only some 10 m wide at high tide (Figure 2.7). Discussions with locals indicate this area, and the area to the north where the Priority 2 stretch of road is submerged at high tide, have gotten lower over time (i.e. the water is deeper today over the road and in the lagoon than it was previously). However, it is not expected that this area will continue to erode, since there is little loose sand in the lagoon, and much of the road area is a compact layer of gravel and beachrock reef – Kone trees with their exposed roots are the also abundant in the northern area (Figure 2.8).

In addition, as described in the feasibility study (Mead *et al.*, 2014), ribbons of sand on the reef flat below the beach rock reef were observed below both the breaches in the beach rock reef, which supports the likelihood that sand is being loss from the causeway site out of these gaps and leading to the lowering of the areas of the northern low road and lagoon. However, it is not expected that the road or lagoon will continue to deepen greatly since there is little loose sand in the lagoon, and much of the road area is a compact layer of gravel and beachrock reef. Even so, simple measures to reduce the potential further loss of sand in these areas can be undertaken during construction, which will entail plugging the 9 m wide gap in the beachrock reef crest (Figure 2.3) with 0.9-1.1 m diameter rock.

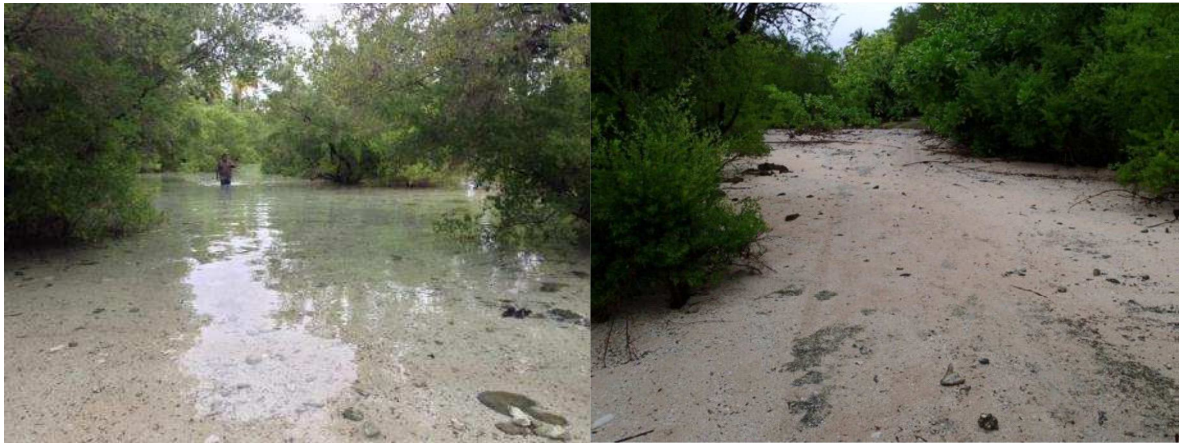
Figure 2.5. The 150 m long Priority 2 section of low road at the north of the project site during high tide (left) and low tide (right).

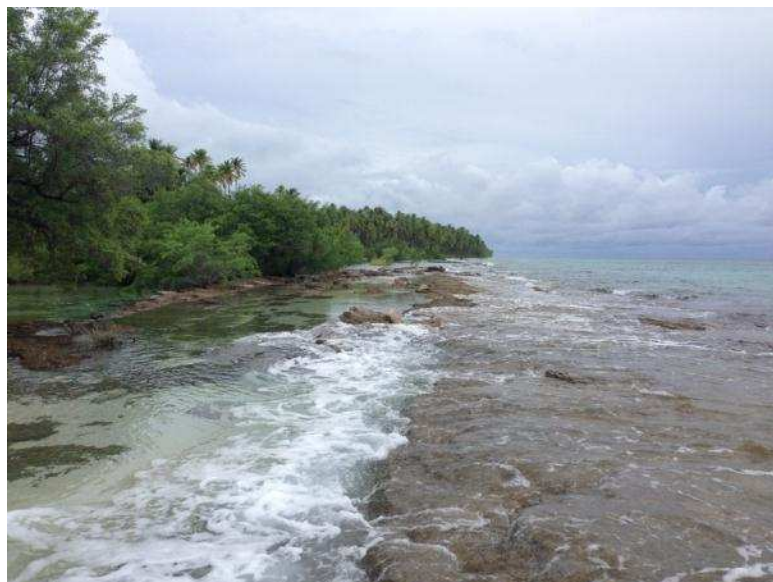
During high tides, the sea over-tops the low beachrock crest (Figure 2.6) and floods the northern part of the causeway over a ~150 m stretch of road, making it inaccessible to vehicles for 1-2 hours either side of high tide. There is a narrow footpath access on the eastern side of the site. However, it is not suitable for development into a road since it is very close to the lagoon beach and vulnerable to erosion, as is the southern part of the existing causeway.

Figure 2.6. Over-topping of the beachrock reef on the western side of the project area; during high tide, the northern 150 m of low road and the tidal lagoon adjacent to the Priority 1 area floods.

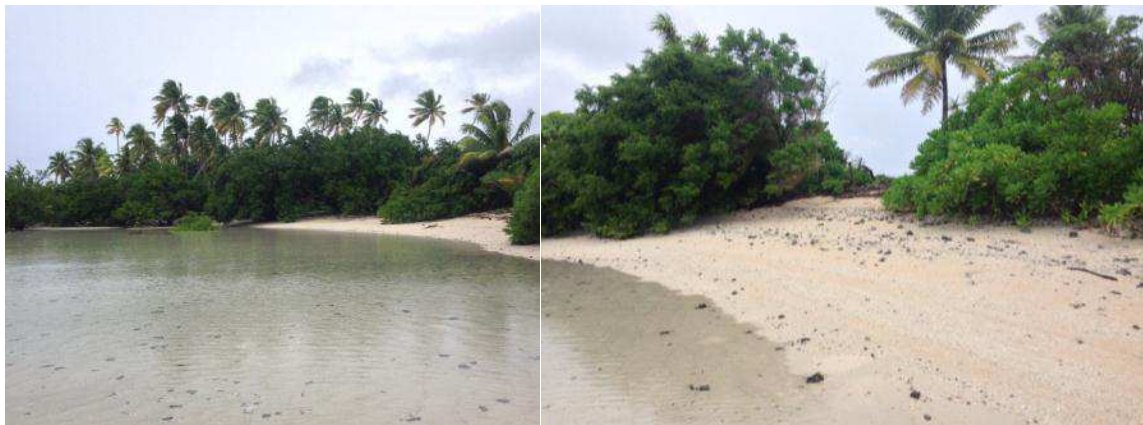
Figure 2.7. Looking north from the tidal lagoon on the western side of the Priority 1 site at mid-tide – the road is directly behind the trees on the right of the photograph, with the width of the island being only some 10 m along this stretch at high tide.

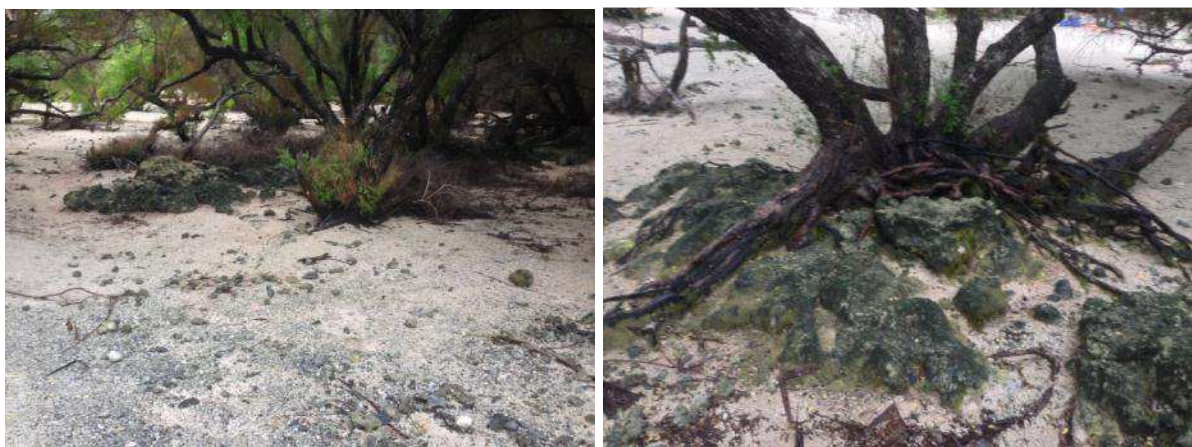
Figure 2.8. The compact gravel and beach rock northern section of road and Kone trees growing on exposed rock.

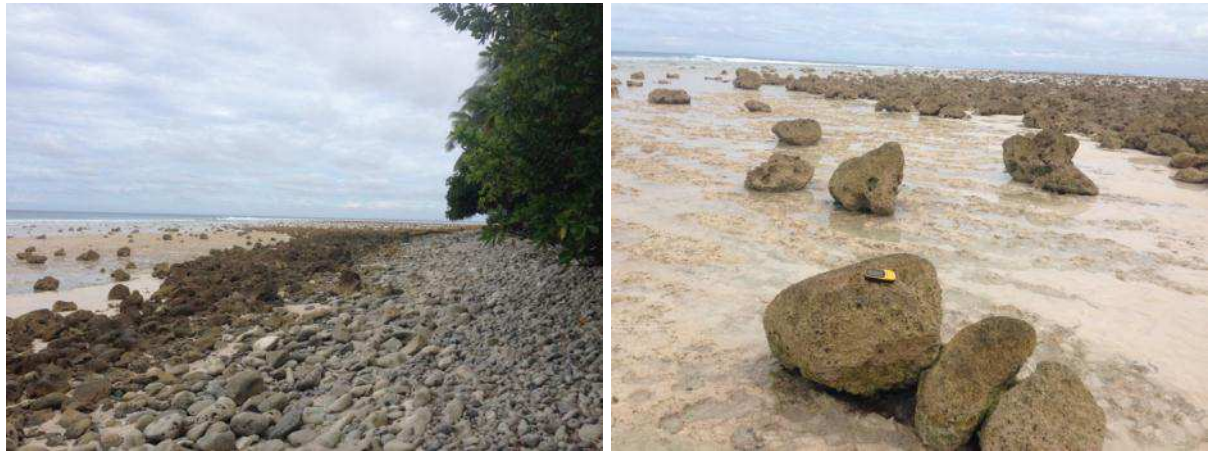
Figure 2.10. A very large supply of rock is available on the northwestern coast of Woja Atoll. The GPS on the rock in the righthand photo is 15 cm long (i.e. the rock it is sitting on is approximately 1.1 m diameter).

Limestone rock (i.e. reef blocks located on the north western coast of the island - Figure 2.10) of 0.78 m diameter (i.e. nominally 0.6-0.9 m in diameter) at a gradient of 1.5:1 (H:V) has been specified for the Priority 1 southern causeway road based on the application of the Hudson formula (Mead *et al.*, 2014). Smaller diameter rock is required for the elevated road (i.e. nominally 0.3-0.5 m diameter) at the northern Priority 2 site, since it is protected from direct wave attack by the beachrock reef to the west and is 40-80 m away from the eastern coast of the island.

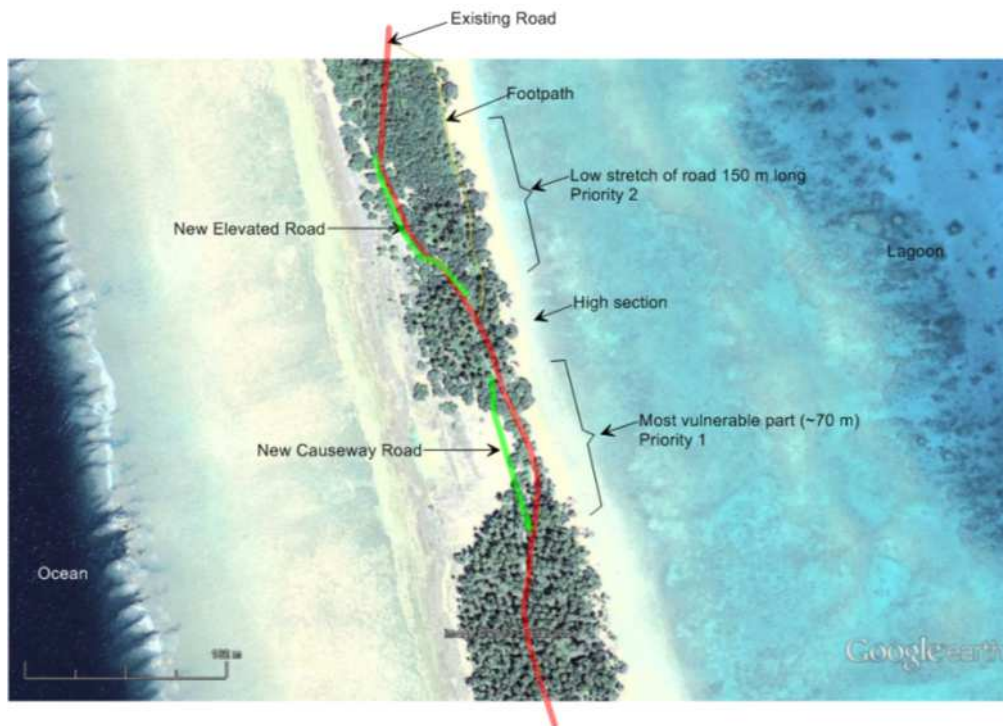
At the Priority 1 southern site, the new causeway road will be set some 15-20 m to the west of the existing causeway road to provide an additional erosion buffer on the eroding eastern side of the causeway (Figure 2.11). The new elevated road in the northern Priority 2 area will run along its existing route (Figure 2.11). In addition to elevating and armouring the causeway road, planting out of the existing road in the Priority 1 area (which will be replaced by the new causeway 15-20 m to the west) will be undertaken to provide additional buffering from erosion, preventing wind-blown loss of sand and providing added natural erosion resistance. Additional soft-engineering in the form planting around the site should also be applied, with mangrove in the low wet areas along the western side of the footpath, and additional

Figure 2.11. The existing road is shown in red – the northern section previously ran along the eastern edge adjacent to the lagoon, where there is now a footpath; it was abandoned due to erosion and over-topping making it impassable during higher tides and large wave events. In the Priority 1 southern areas, the new causeway road will be set some 15-20 to the west of the existing causeway road (shown with the green line) to provide an additional erosion buffer on the eroding eastern side of the causeway. The new elevated road in the northern Priority 2 area will run along its existing route (also shown with a green line).

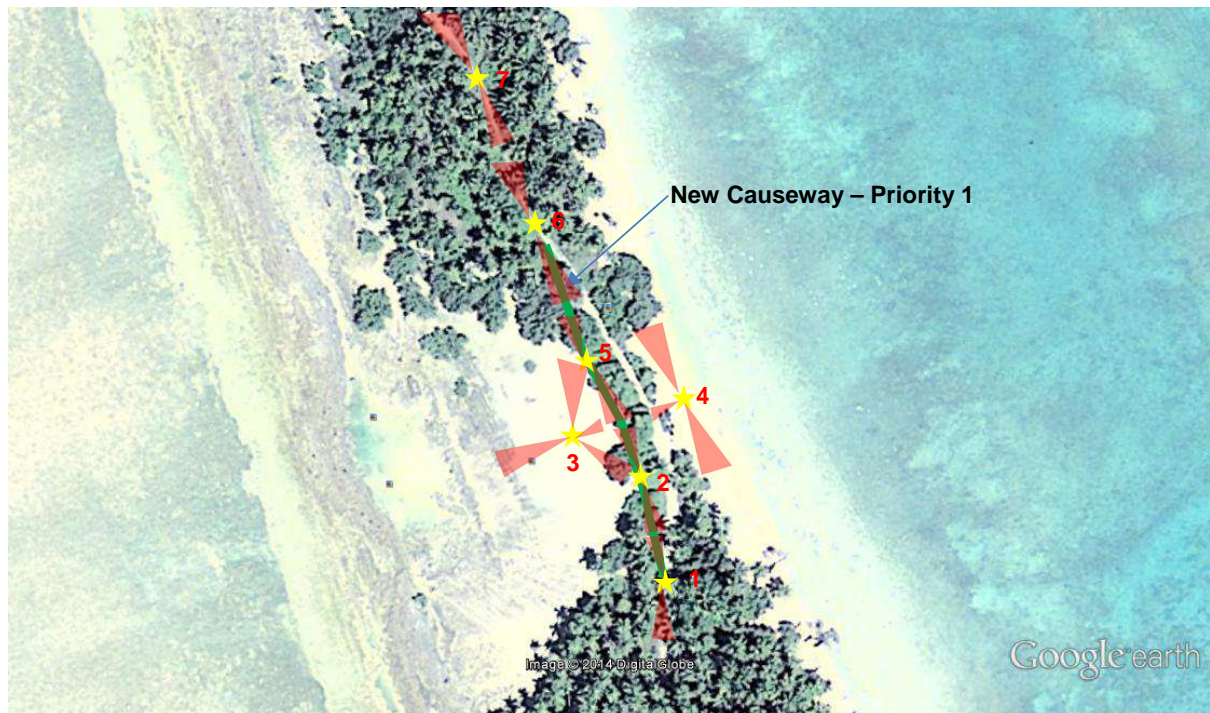
Photographs and field notes can be collected by local representatives for the purpose of monitoring – a digital camera may need to be purchased for the Woja Island community to undertake this monitoring. A guide to the locations of monitoring photographs are shown in Figure 4.2 and Figure 4.3 – these sites are considered a guide, since the local topography and vegetation may restrict the field of view in some cases, and there are probably other locations that will provide better fields of view. These photograph locations relate to existing archived photographs collected during the feasibility study. It is important that photographs are taken from a similar location with a similar field of view each time monitoring is undertaken. Additional locations and more photographs can be taken – the important aspect of the monitoring is repeating the same fields of view each time the monitoring is done.

Figure 4.2. A guide to photograph locations for the Priority 1 site. The stars indicate the location and the red-cones the field of view.
