Rapid Vulnerability and Adaptation Assessments of six Communities in Tongatapu, Ha'apai, and Vava'u, Tonga

Executive Summary

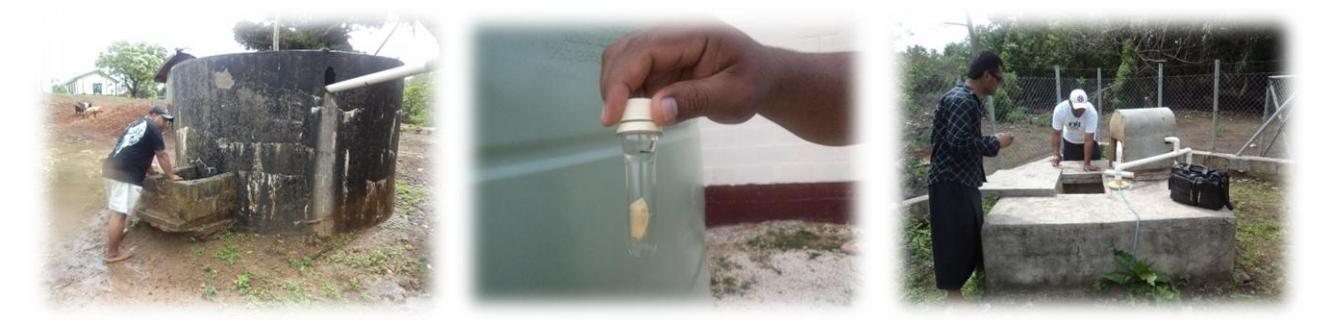
From left to right: The Ovaka community hall rain water tank; Tongata'eapa plastic rain water tank; and Ha'afeva ground water source.

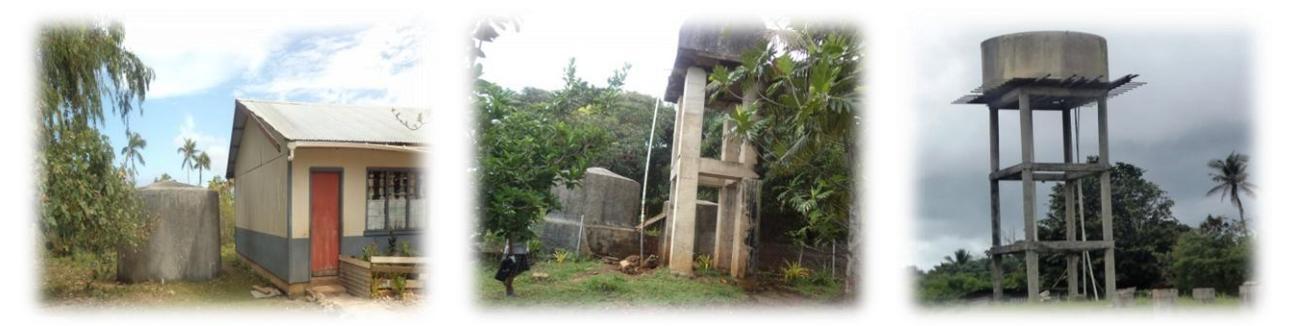
From left to right: Popua Primary School; Tu'anekivale ground water source; Tatakamotonga water source

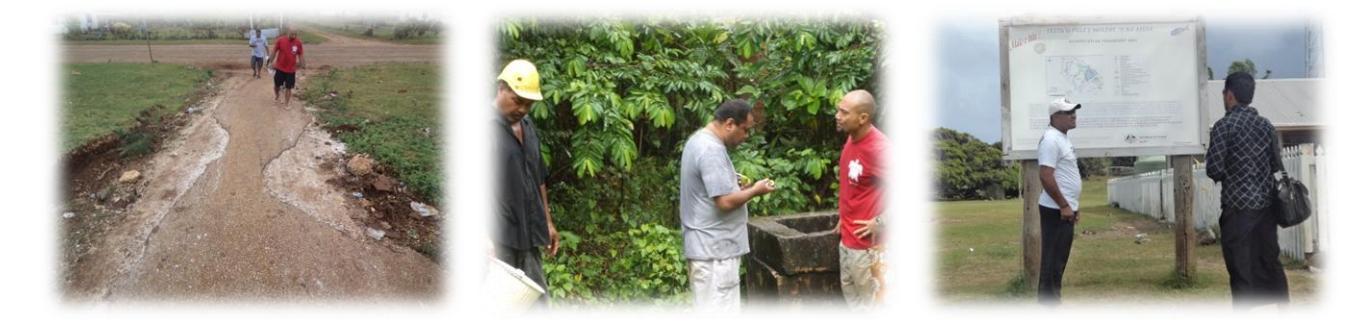
From left to right: Tu'anekivale soil erosion; Ovaka ground water well; Ha'afeva Coastal Management Sign board

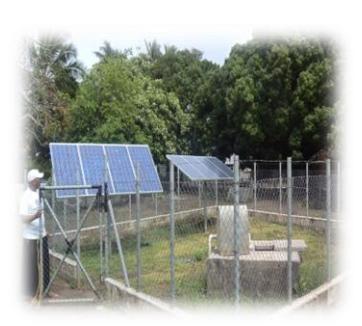
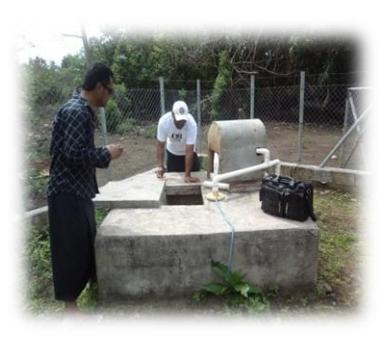
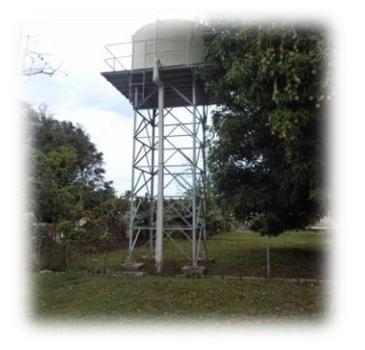
Ha'afeva's ground water source is located in the center of the settlement area itself which lies in a SW to NE

direction along its southeastern coastal area. It is surrounded by homes and piggeries which is not very safe. The well is being sealed with cement to safeguard from contamination from the surrounding area, but it is too close to homes and leakage into the water source is possible as it is not located on an elevated site and the well is very shallow.

This is an old well they used to pump into a 3000 liter elevated water tank reservoir located about 100 meters

south of the well on higher grounds. Solar panels were installed to provide power for the pumps during the day. It is no longer working and needs maintenance. Electric connections are used when power is on from 7pm-12am at night.

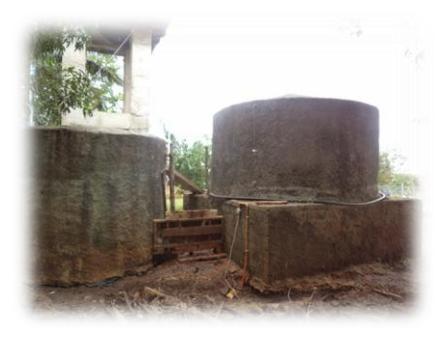
Ground water cement tank reservoirs are broken and leaking, while the pipes that transport the water into the homes are old and most of them may be leaking. Water pressure in some parts of the village is not strong enough thus water is not running at most times.

Most of the church halls and buildings have rain water tanks that the community can access. However, some of these tanks may need to be maintained as well as the gutters. Some of the

individual cement water tanks needs maintenance or are totally broken and needs replacing.

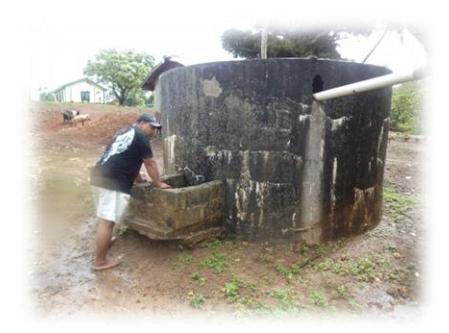
Rain water harvesting is the only source of clean and safe water supply for the Ovaka community. They are still waiting on a project to install their ground water supply system. They were on the verge of running out of

water before the rain arrived together with our rapid assessment team thus saving them from having to revert to using an old ground water well they used before in times of droughts. Some of the

tanks are old as well as gutters and roofs needs maintenance. Large buildings such as halls and churches have rainwater tanks, but they need to be maintained and may also need to install more tanks for drought periods.

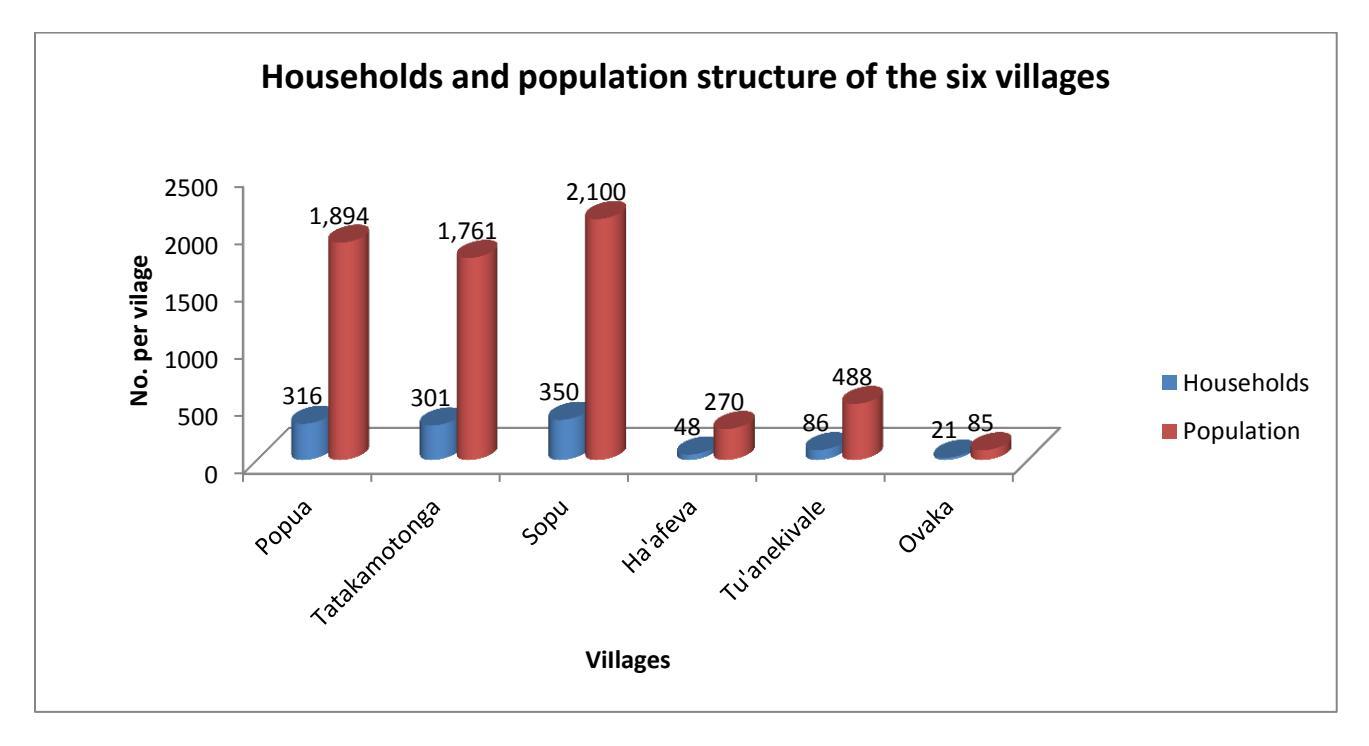
Figure x: Number of Households and Population Structure of the six communities that were assessed

The number of households and population structure for the six communities are shown in figure X below.

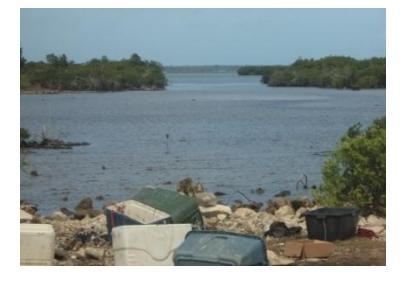
Indiscriminate dumping of solid waste was still evident in all six communities. Although, Popua, Sopu and Tatakamotonga in Tongatapu have access to a

modern state of the art waste management system there are still evidence of indiscriminate refuse dumping of solid waste on vacant land in both the village and in the bush allotment, as well as near the coast.

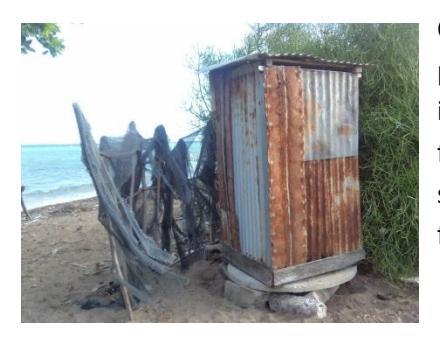
Open pit toilets are still widely used in most of these villages. They are especially prominent in the outer islands especially Ovaka, Ha'afeva and Tu'anekivale. This is an issue with water sources as most of these villages don't have running water for 24 hours 7 days a week. However, in villages with running water there are still households with open pit toilets, where the issue is being able to afford a flush toilet system.
