# Kosrae Shoreline Management Plan

Repositioning for resilience

NIWA Client Report No: HAM2013-133  
Report date: November 2013  
NIWA Project: DGI13201

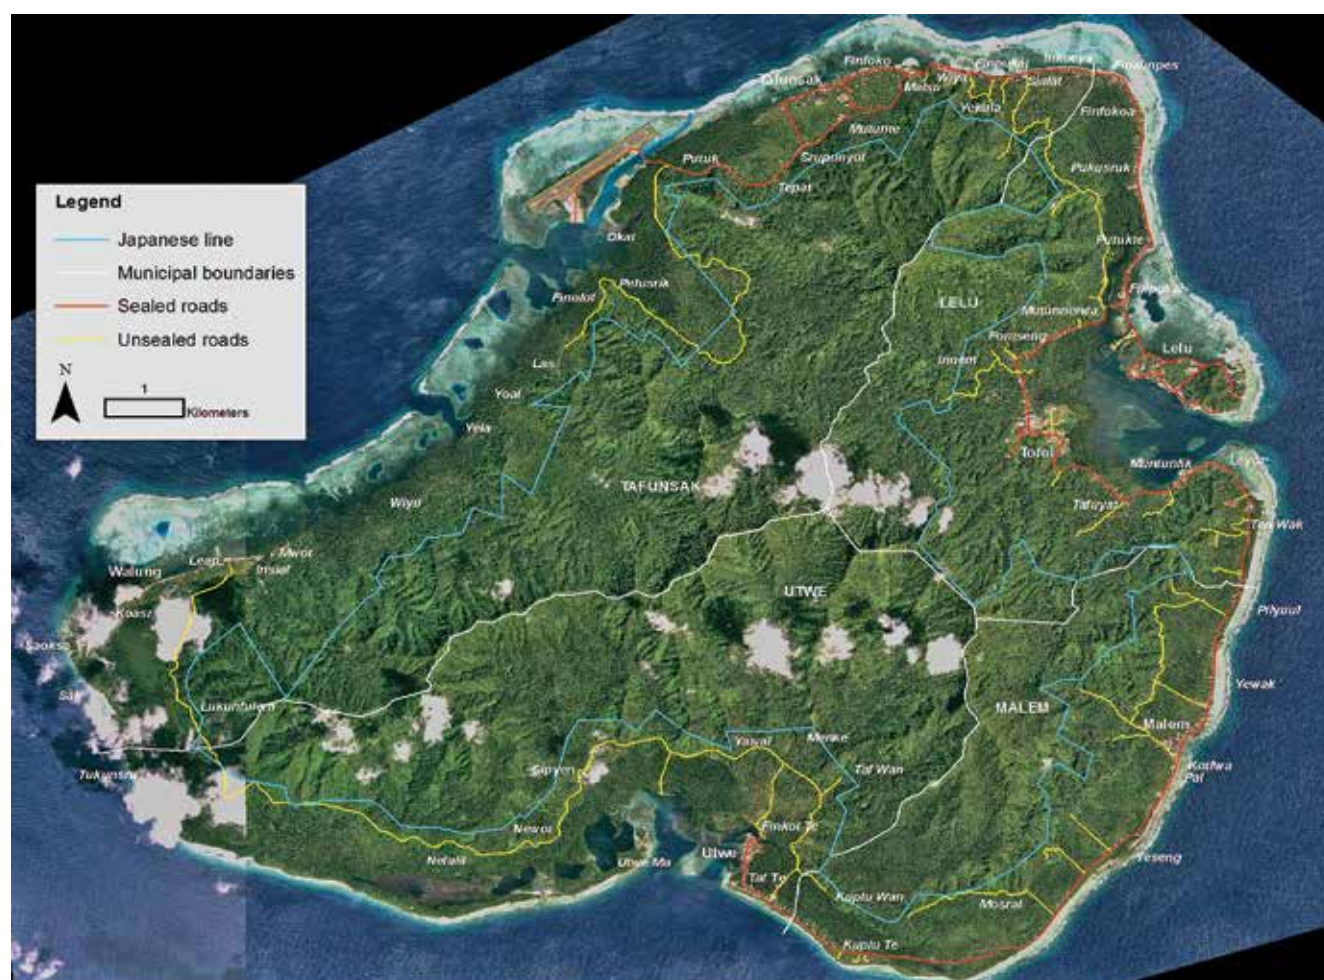
Figure 1: Map showing locations of municipal boundaries, roads, villages and place names on Kosrae.

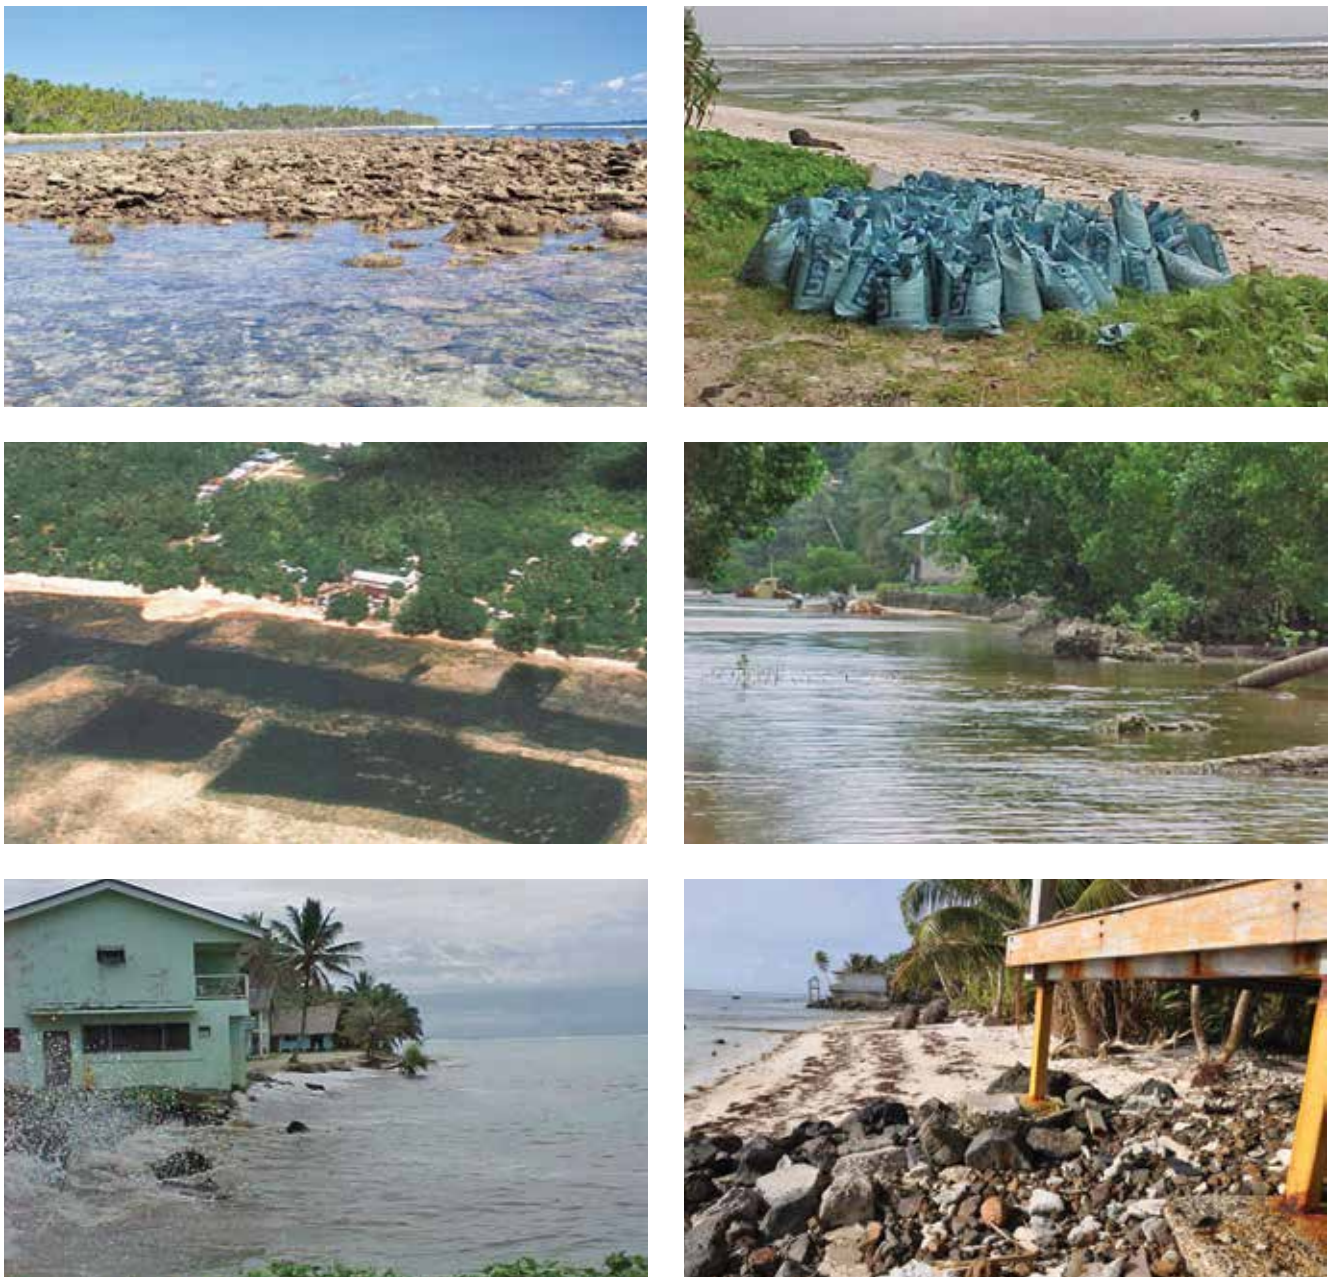
Figure 4: Examples of human impacts that have caused or exacerbated the potential for coastal erosion and inundation impacts on Kosrae. Top left: removal of coral rubble from the reef flat; Top right: Sand mining; Middle left: Dredge pits on the inner reef flat at Tafunsak; Middle right: Erosion at Walung caused by the cutting of a drainage channel at Leap; Bottom left: Erosion at the Sandy Beach Hotel caused by the seawall; Bottom right: Erosion and coastal change at Finfokoa caused by the reclamation at the old Pheonix Resort and recent house construction.

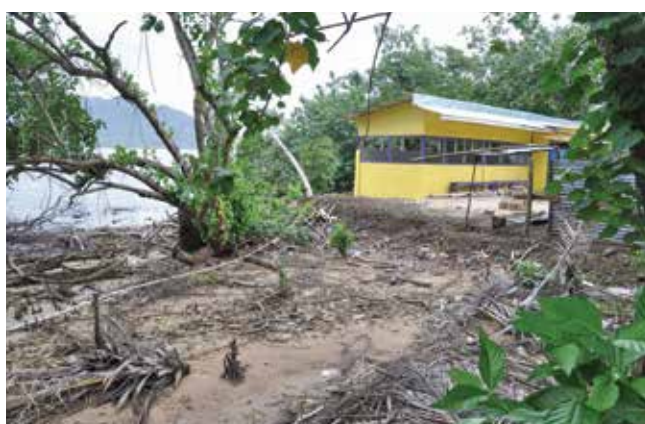
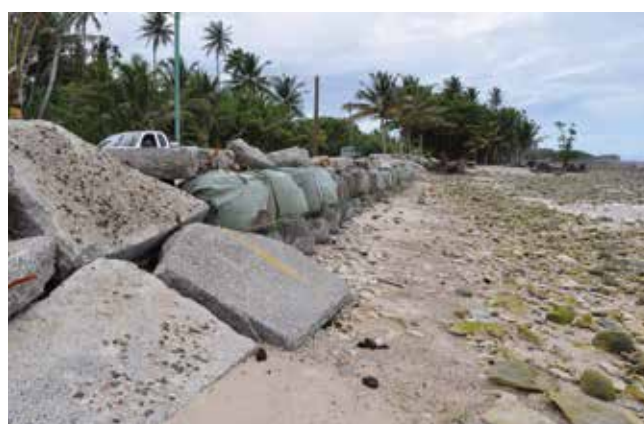
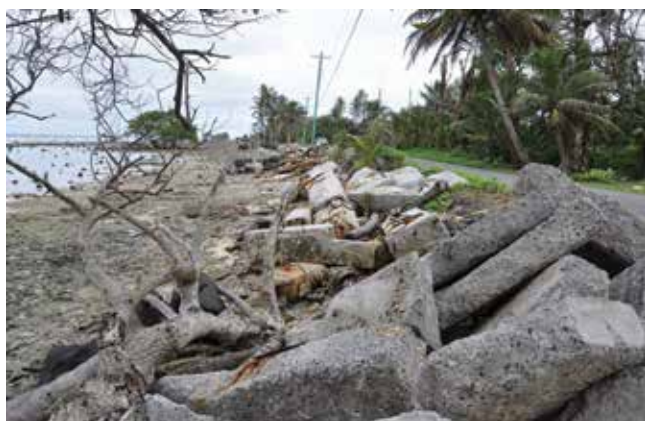
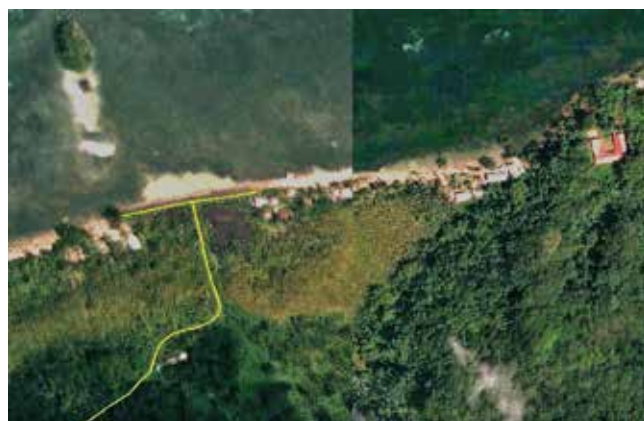
Figure 5: Recent examples of poor development activities that will lead to further coastal hazard-related problems and are not sustainable or effective in the long-term. Top left: Low-lying reclamation for a new laundromat at Tafuyat, Lelu Harbour; Top right: Concrete bag seawall to protect the road at Mosral, Malem; Bottom left: Dumped concrete rubble to attempt to protect the road at Pal, Malem; Bottom right: Access road construction through the mangrove and along the foreshore at Leap, Walung.

- The extension of the road across the wetland/mangrove area and along the shoreline at Leap in Walung (with the intention to continue the reclamation and road development to the church at Insiaf), rather than continuing it around the edge of the volcanic part of the island.

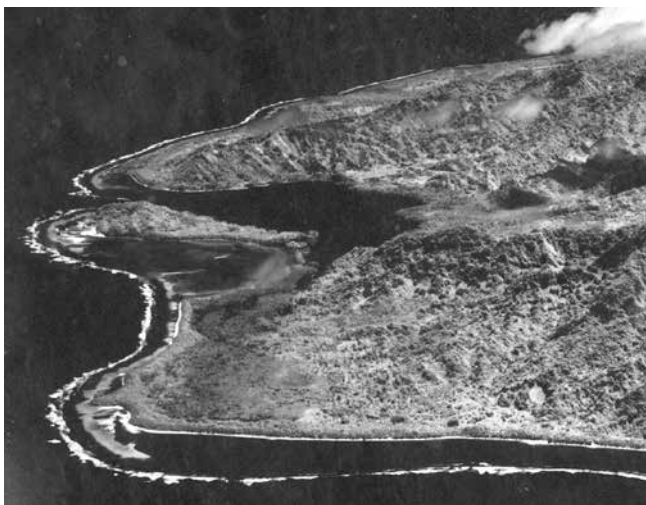
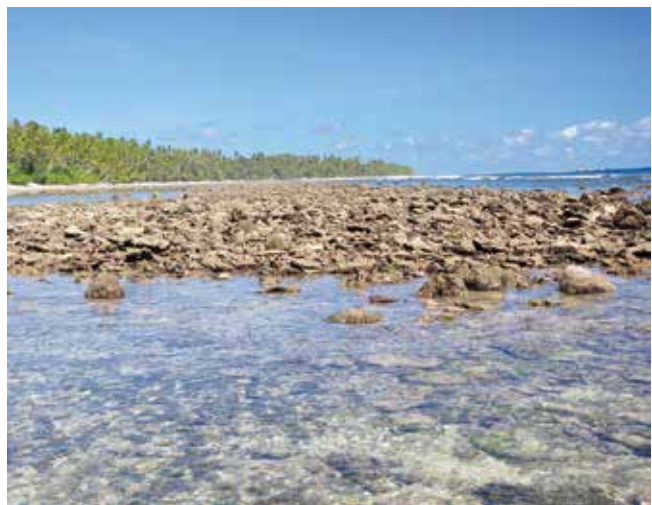
Figure 6: Aerial photograph of the north-east Kosrae coast in 1944 (left) and the remnants of the rubble ridge in 2013 at Putukte (right). The rubble ridge extending from Finaunpes all the way down the Pukushruk shoreline to Putukte can be clearly seen in 1944. The size of the ridge between Finaunpes and Finfokoa resulted in a build out of the shoreline in a bulge in the lee of the ridge. With the breakdown/removal of the rubble ridge, the sediment in this bulge in the shoreline has been redistributed along the adjacent coastline.

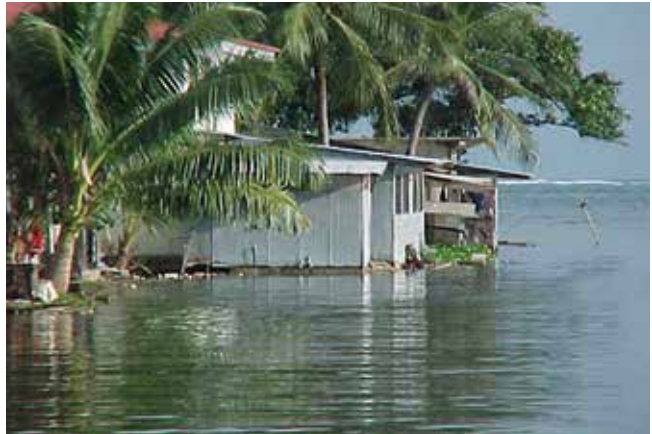
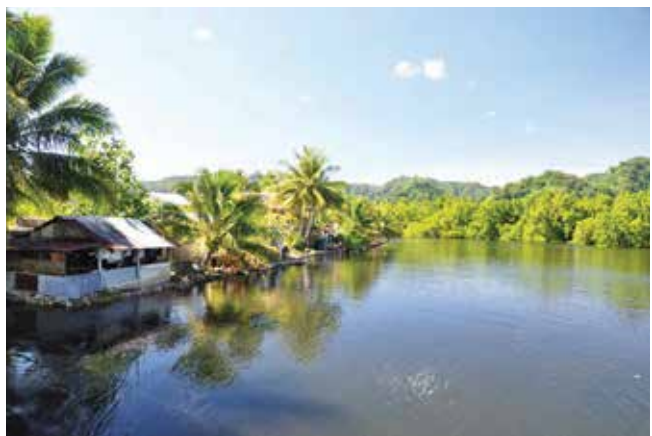
Figure 9: Low-lying reclaimed areas on Lelu Island (top) and Utwe village (bottom). Both Lelu and Utwe villages have been built on reclaimed land that is close to present day high spring tide levels. The frequency and severity of high-tide flooding will be an ever-increasing issue as sea-level rise continues. Constructing further seawalls will not prevent more frequently and severe inundation occurring in the future.

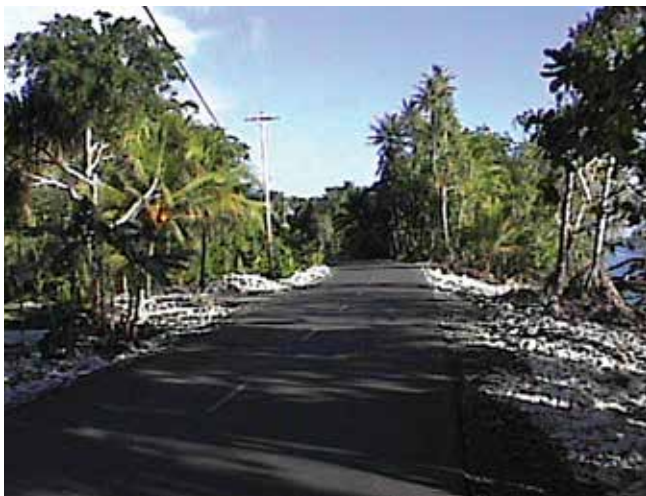
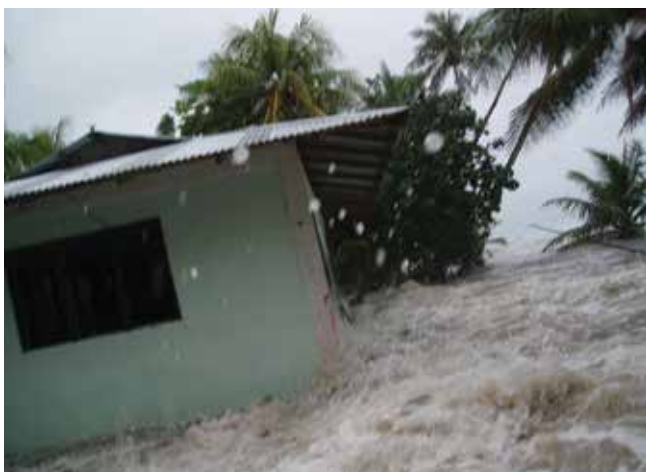
Figure 8: Overwashing of the road in South Malem during Tropical Storm 31W in December 2001 (top) and at Tafunsak during the December 2008 large swell event (bottom).

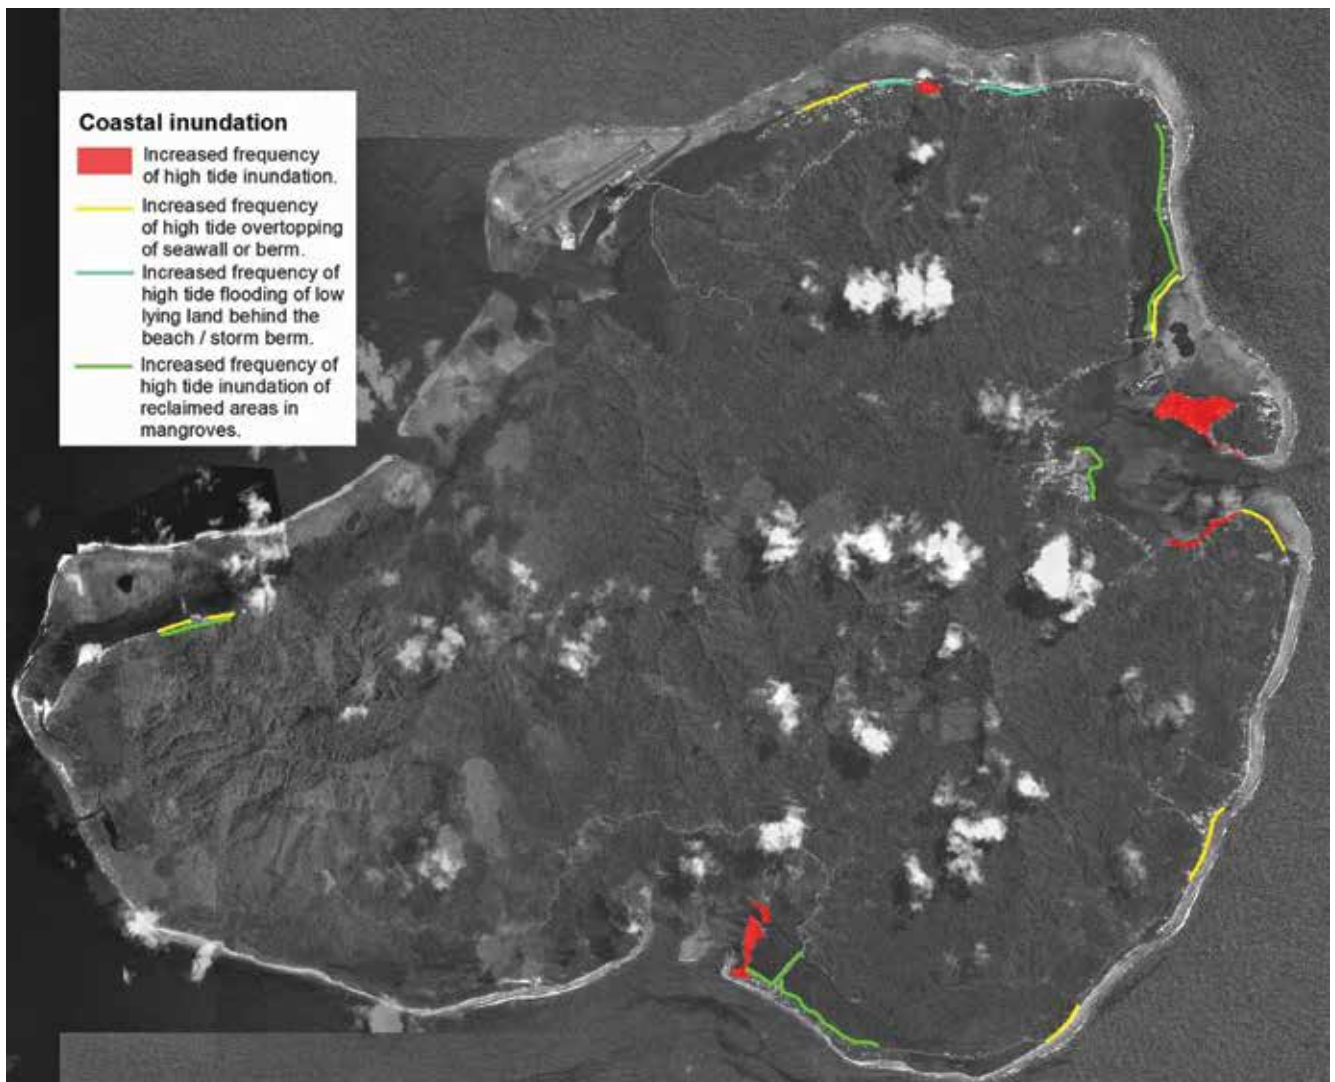
Figure 10: Summary of key locations where coastal inundation issues will increase on Kosrae over the next one to two generations.

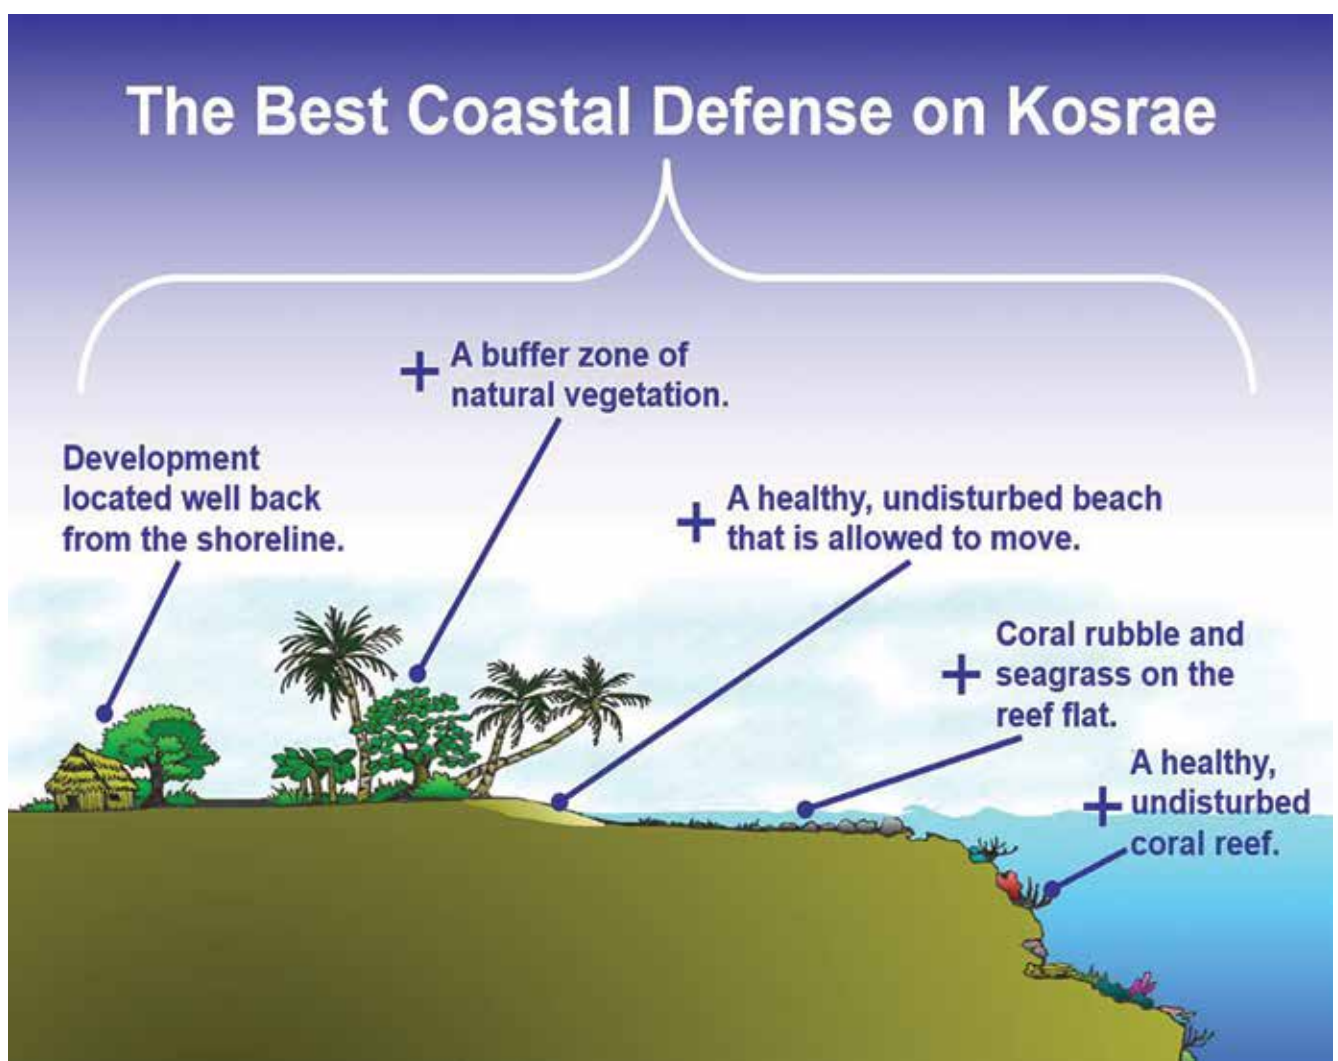
Figure 11: The best coastal defence on Kosrae. Awareness poster developed in 1999 by the Development Review Commission (now KIRMA).

A healthy coastal environment on Kosrae is the most effective coastal defence available. This natural coastal defence includes the watersheds, wetlands and swamp forests, mangroves, beaches, reef flat, and the coral reef (Figure 11 and Table 1). The effectiveness of this natural coastal defence, and its

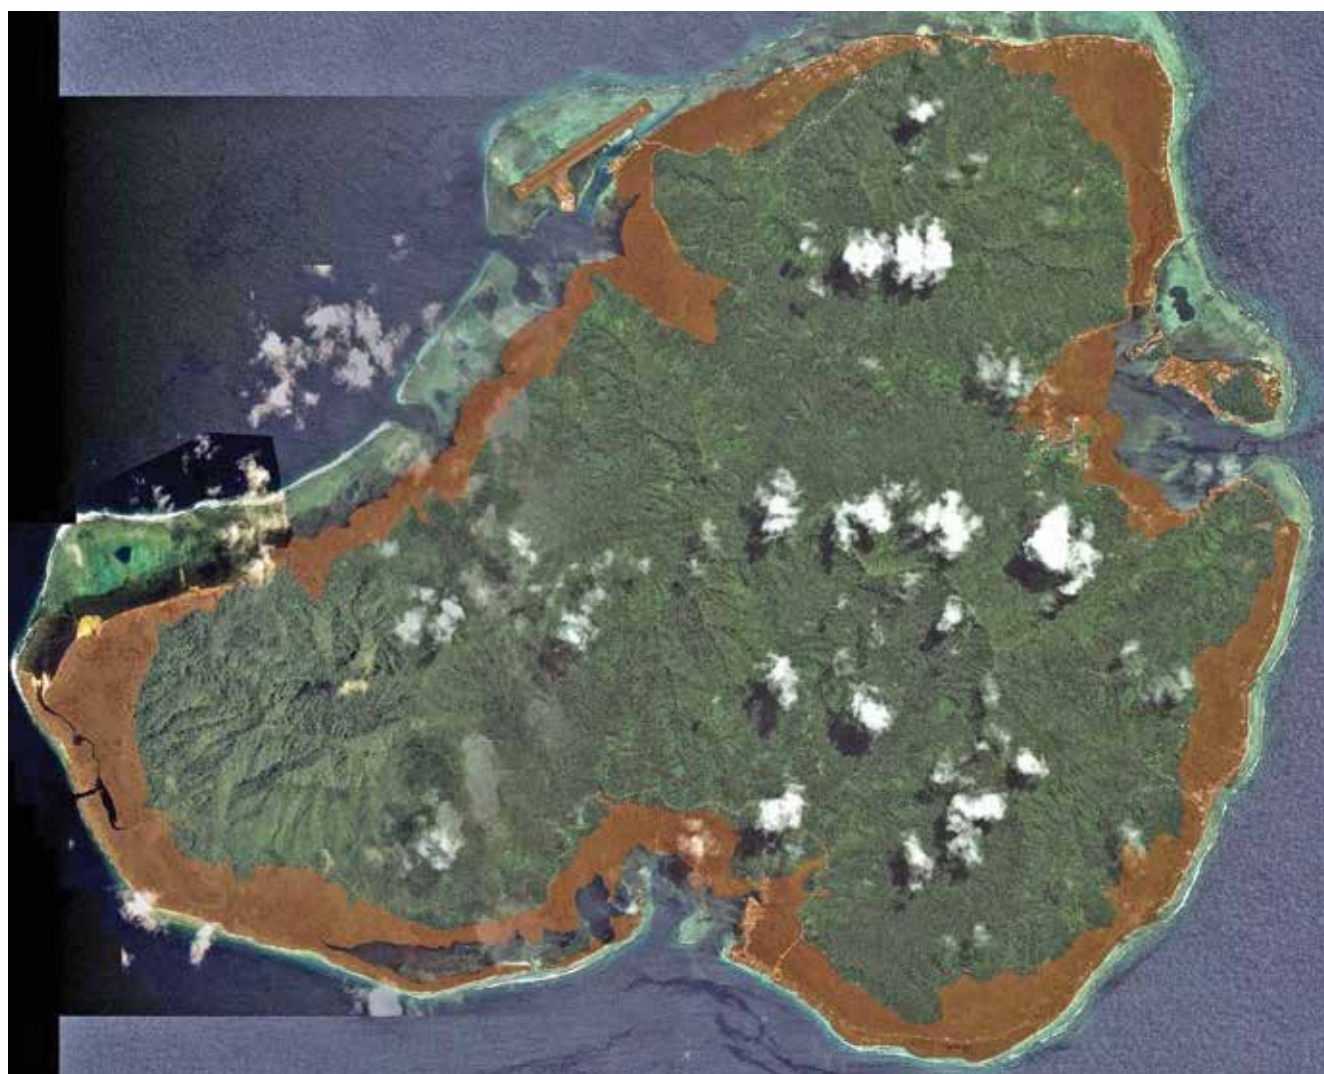
Figure 12: Low-lying coastal areas where restrictions on further development are required. The areas shown in red are largely below the 4 m MSL contour which is approximately 2 m above present day high spring tide level.

The area covered by the above development restrictions is shown in Figure 12.

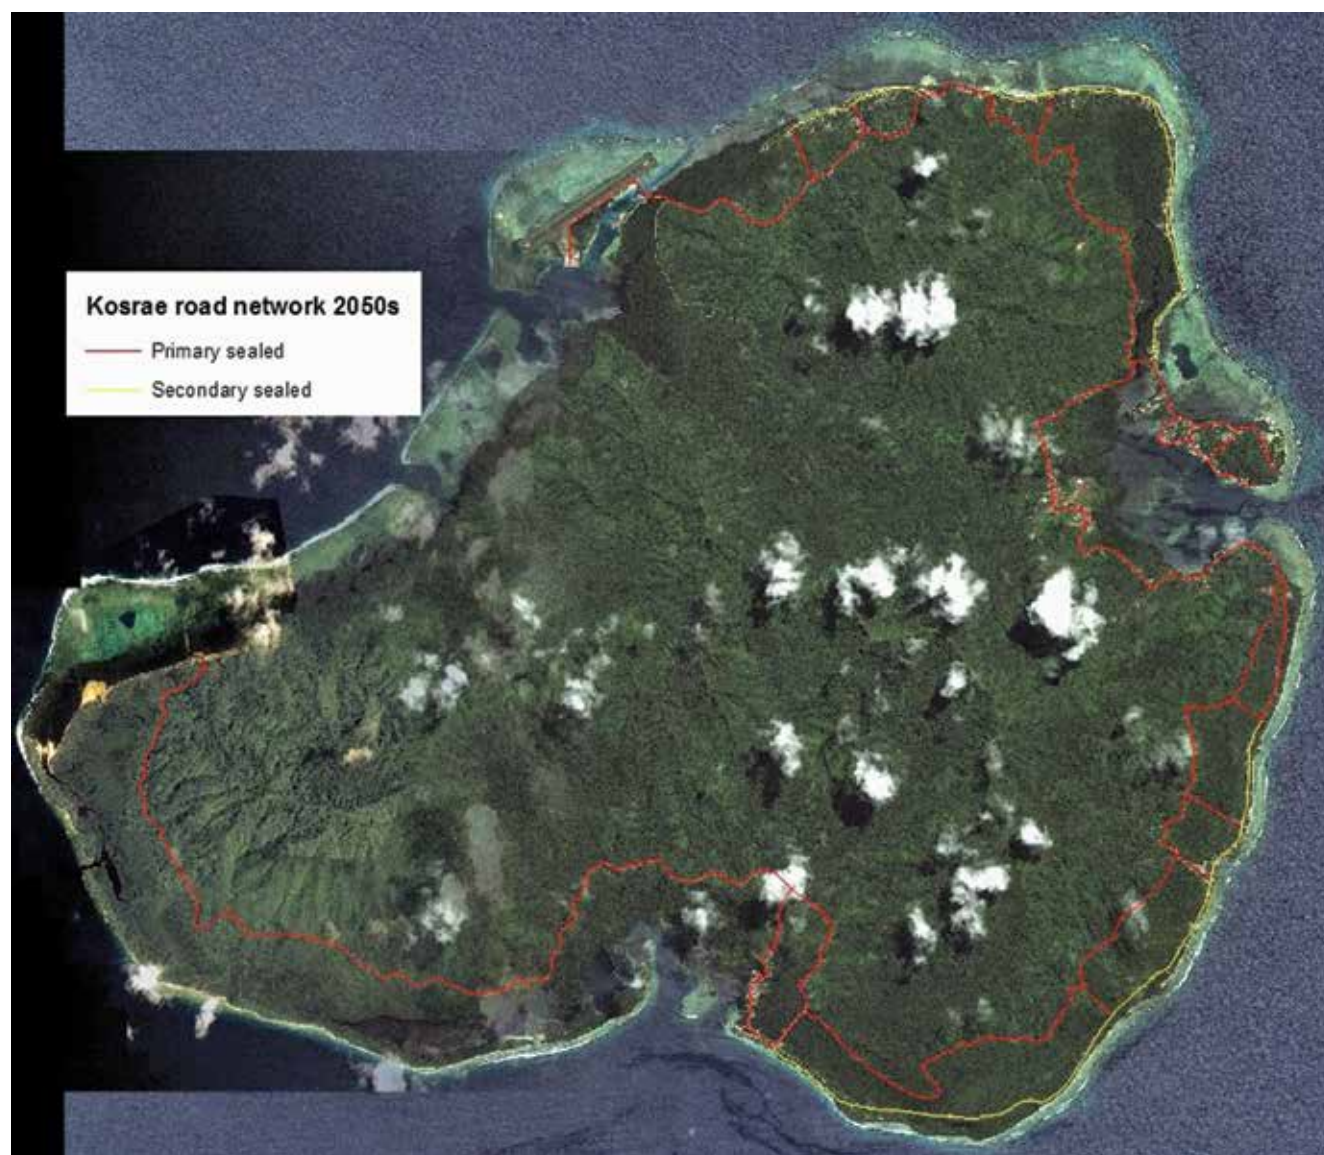
Figure 13: Potential primary and secondary sealed road network on Kosrae by the 2050s. Note: Parts of the secondary road network (current coastal road) may become impassable due to ongoing shoreline change and breaching.

By the 2050s (2 generations time) Kosrae needs to have made significant progress in implementing an adaptation strategy that repositions the majority of existing critical infrastructure and property away from the beach/storm berm areas, reclaimed areas of mangrove and low-lying wetland swamp to slightly higher ground around the base of the volcanic part of the island (Figure 13).

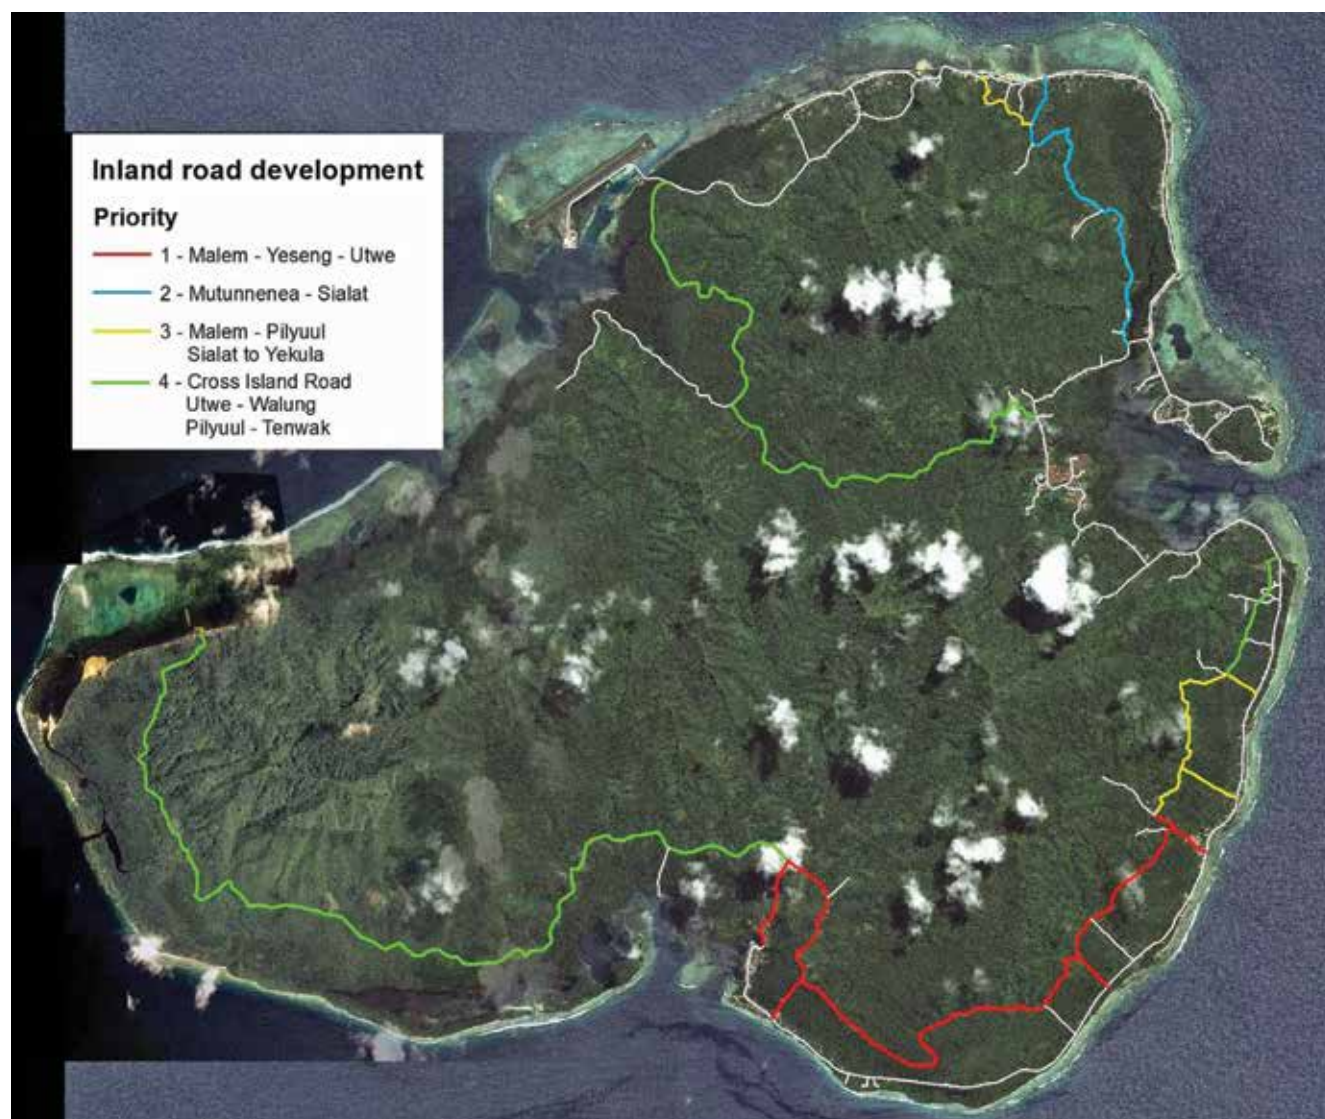
Figure 14: Priority section of the development of the inland road on Kosrae.

The prioritized redevelopment of the coastal road is summarized in Figure 14 and outlined below:

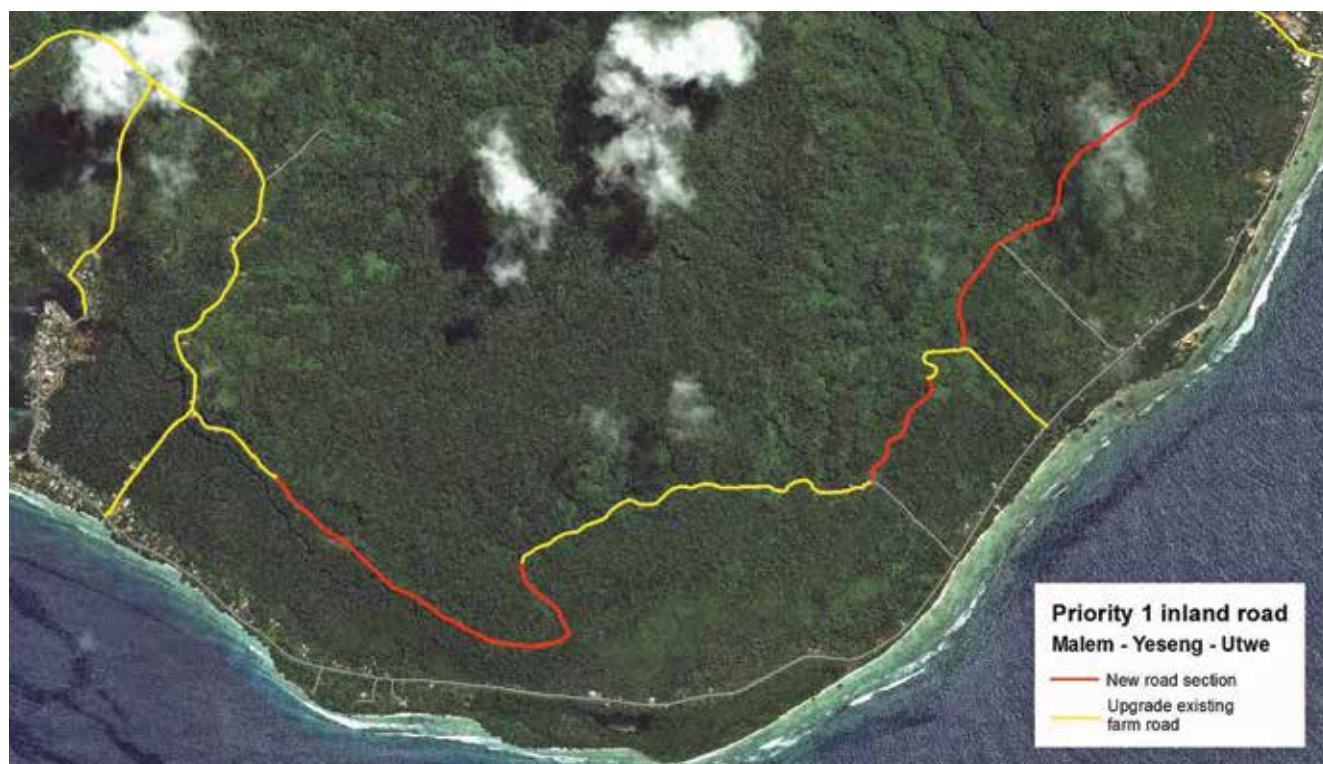
Figure 15: Indicative inland road between Utwe and Malem showing the requirements of new and upgraded sections of road.

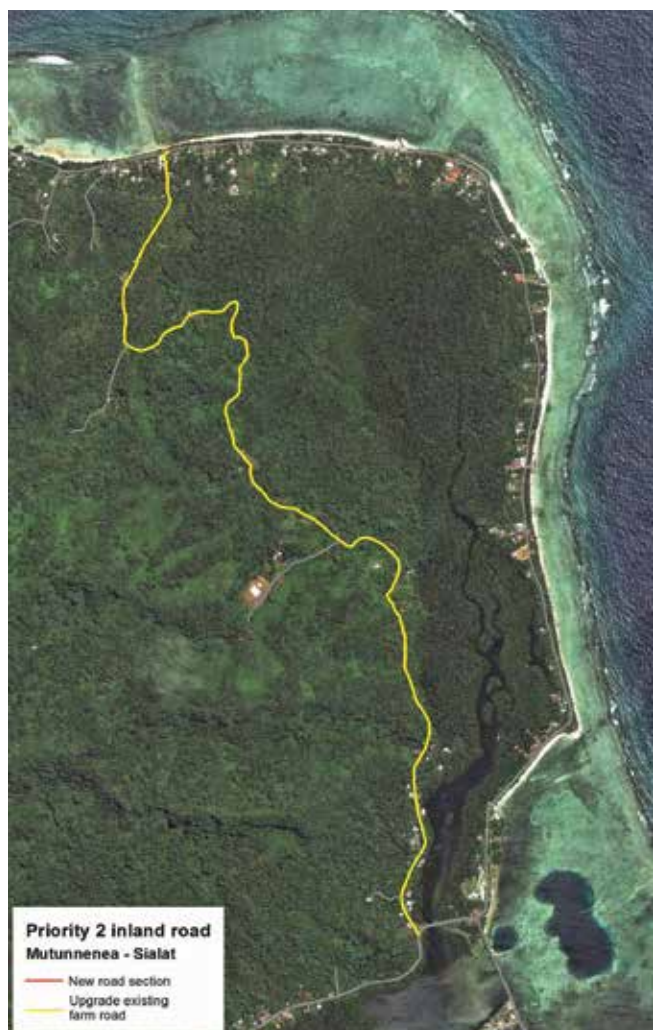
Figure 16: Inland road section between Mutunneneea and Sialat.

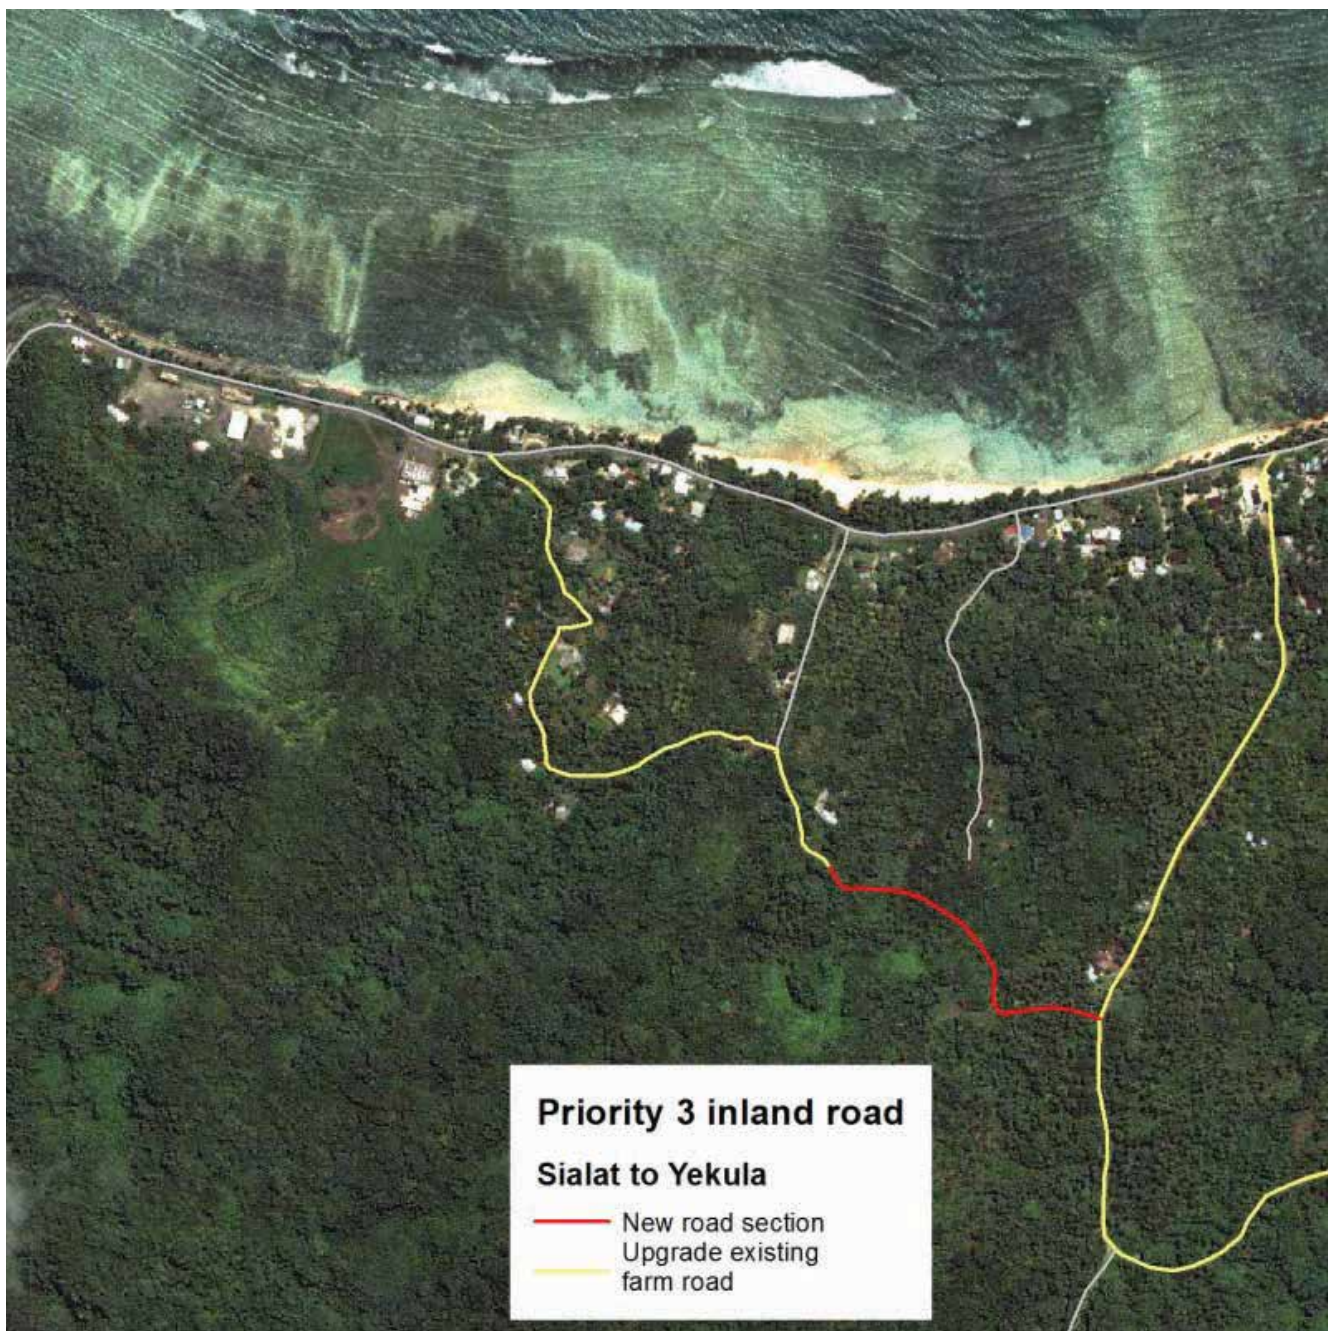
Figure 17: Inland road section between Sialat and Yekula.

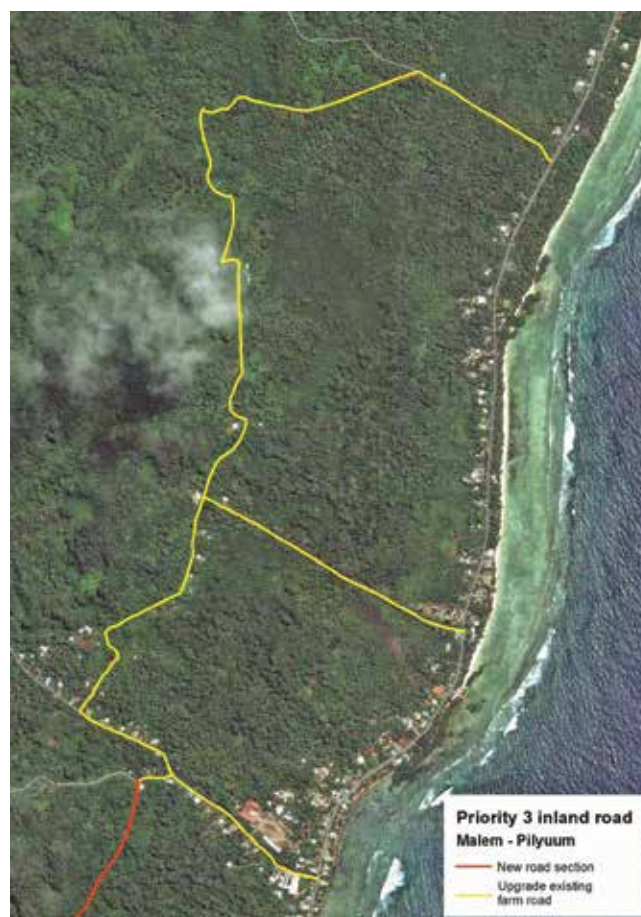
Figure 18: Inland road section between Malem and Pilyuul.

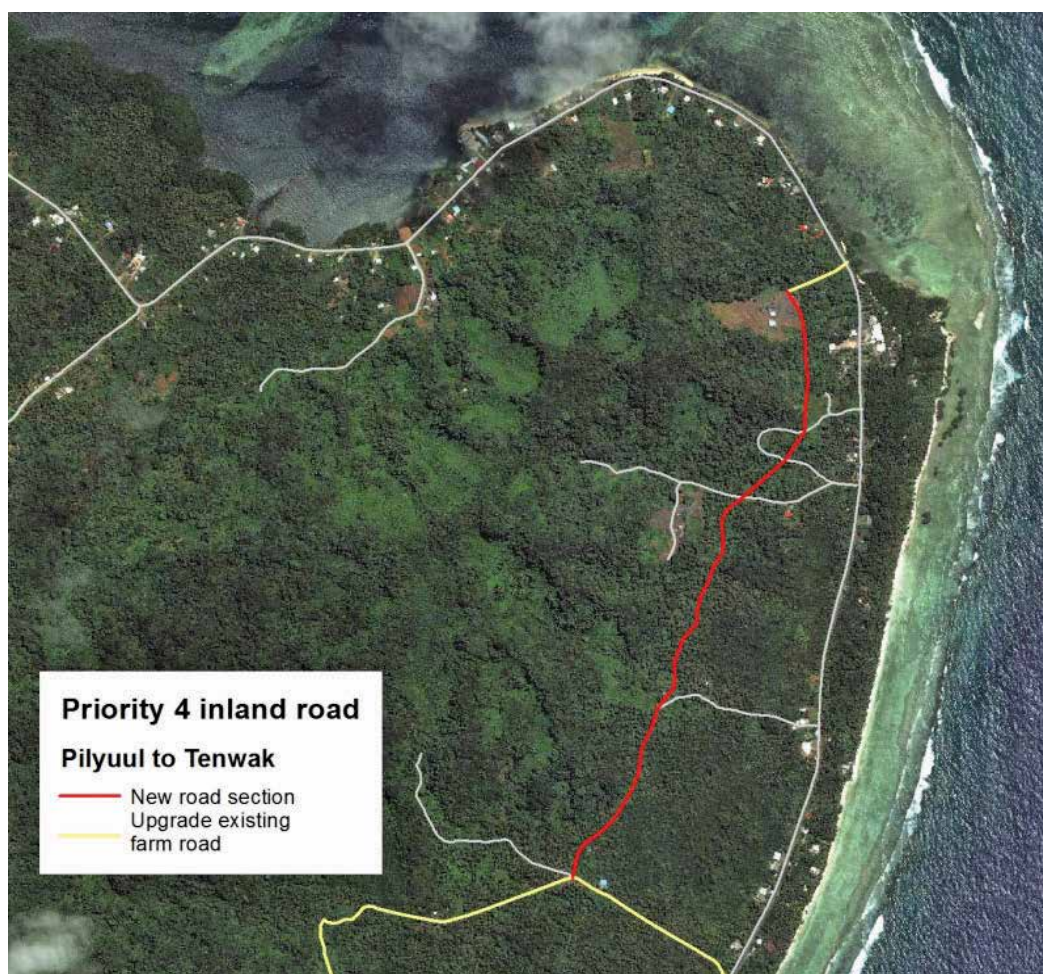
Figure 19: Inland road section between Pilyuul and Tenwak.

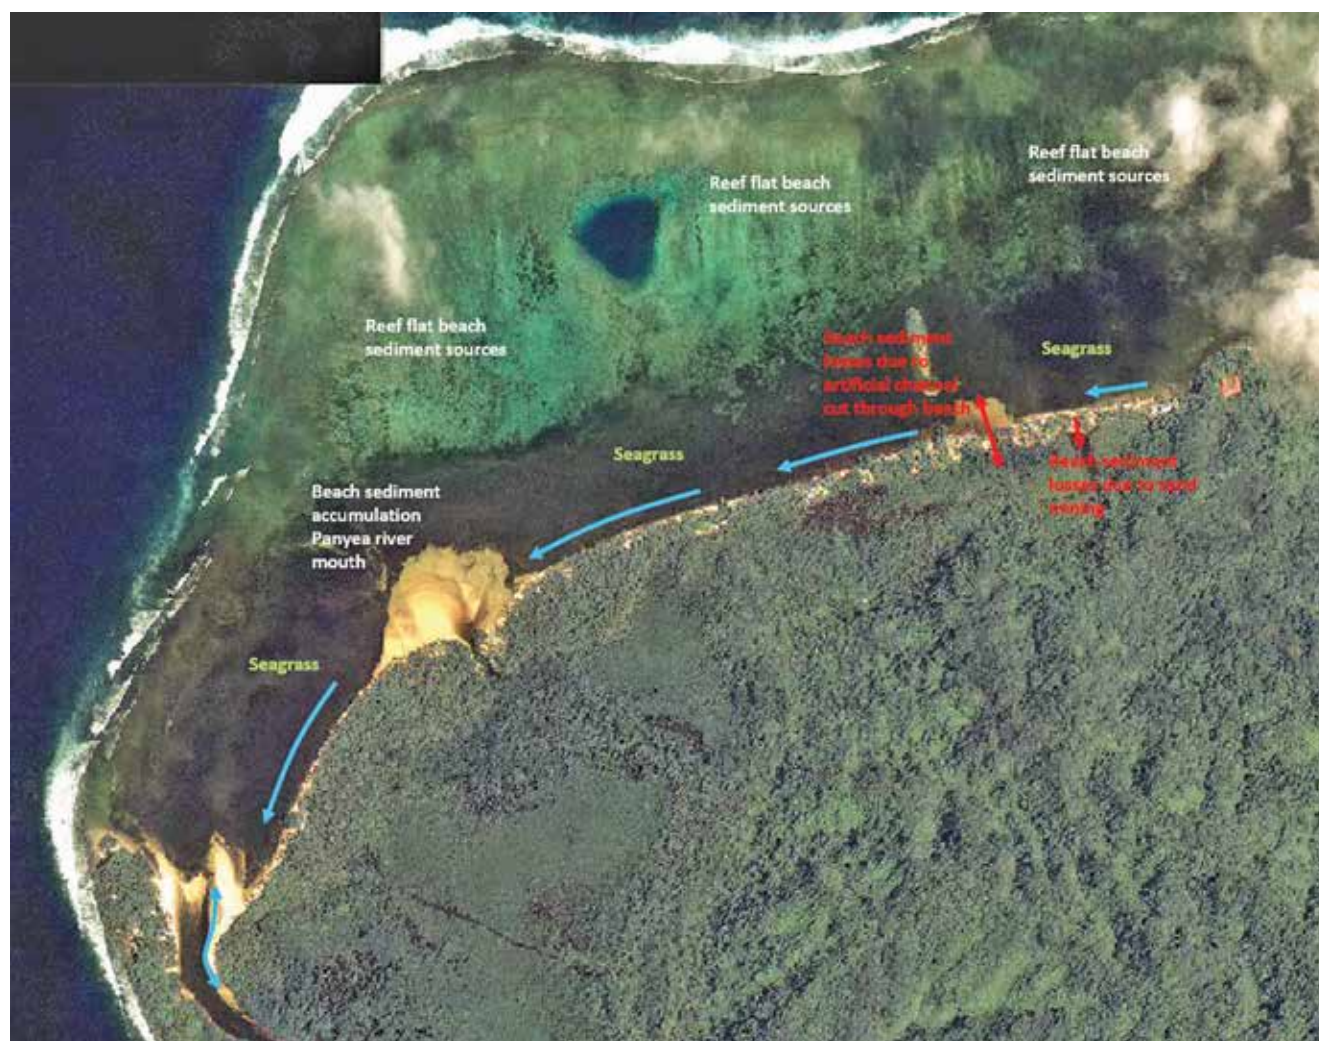
Figure B 4: Key sediment sources, longshore transport processes, and sediment losses along the Walung shoreline.

- The net westerly longshore transport of beach sediment means that downdrift erosion problems are likely where poorly considered seawalls or reclamation is conducted. This occurred at Leap after the opening of the channel

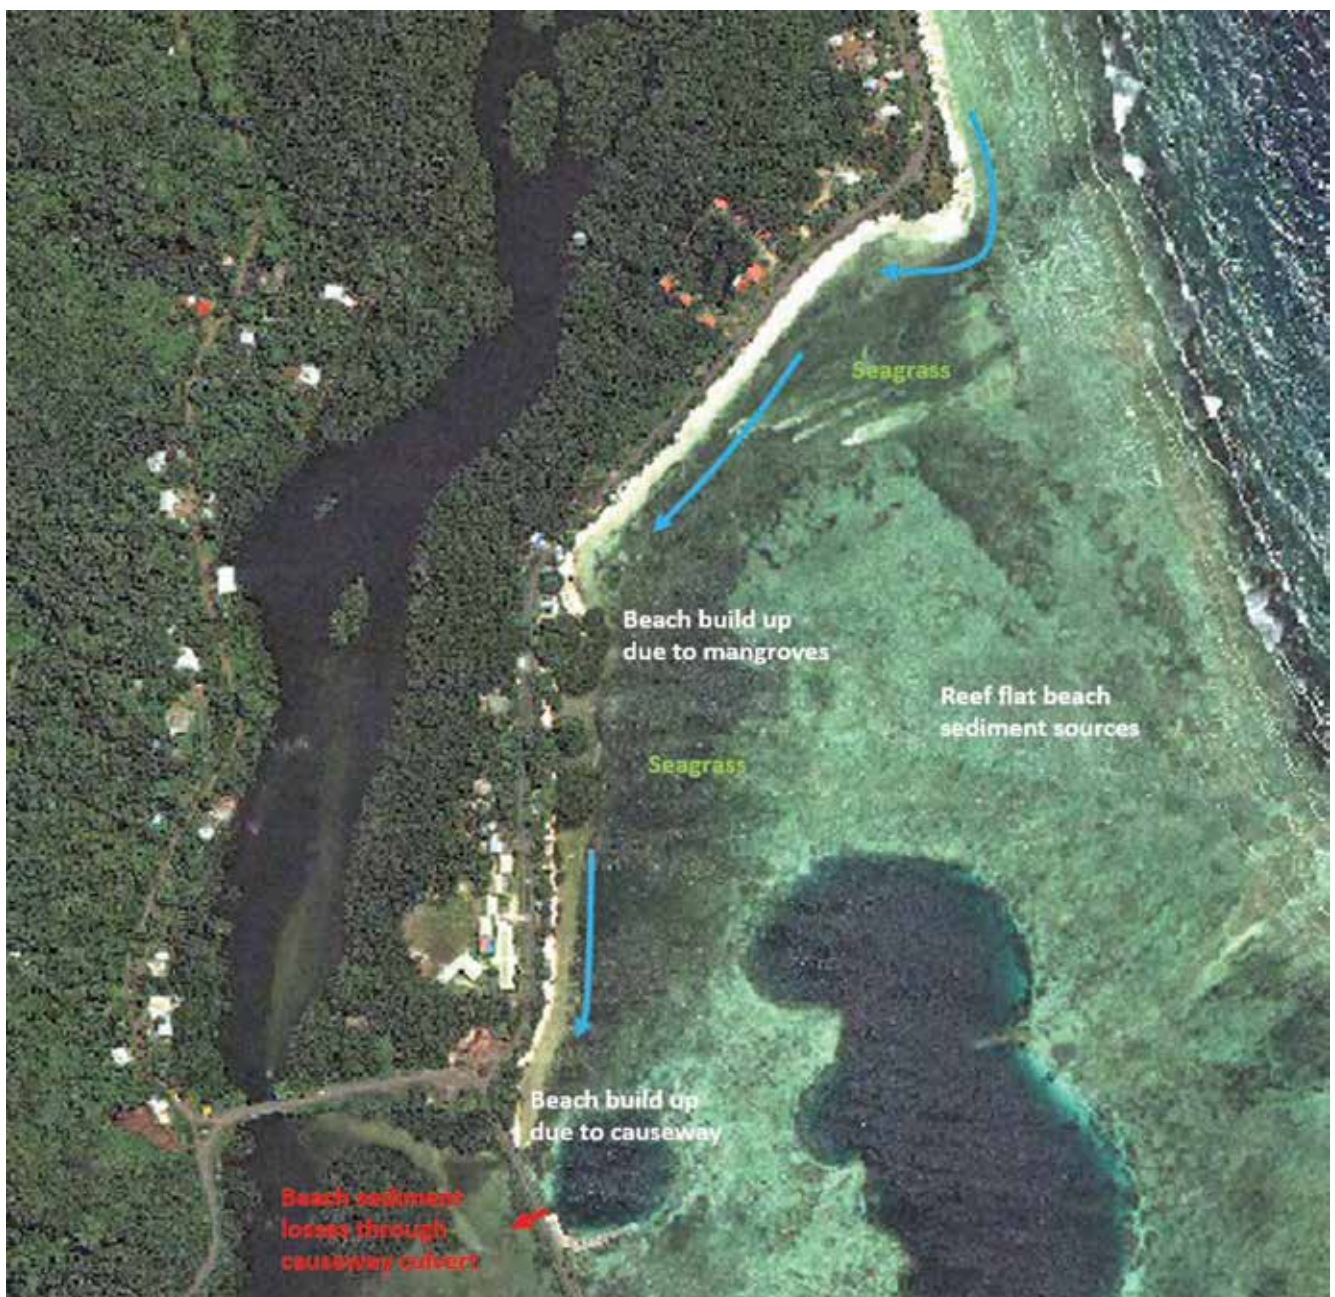
Figure B 5: Key sediment sources, longshore transport processes, and sediment losses along the Putukte to Finpukal shoreline.
