# Kosrae Shoreline Management Plan

Repositioning for resilience

NIWA Client Report No: HAM2013-133  
Report date: November 2013  
NIWA Project: DGI13201

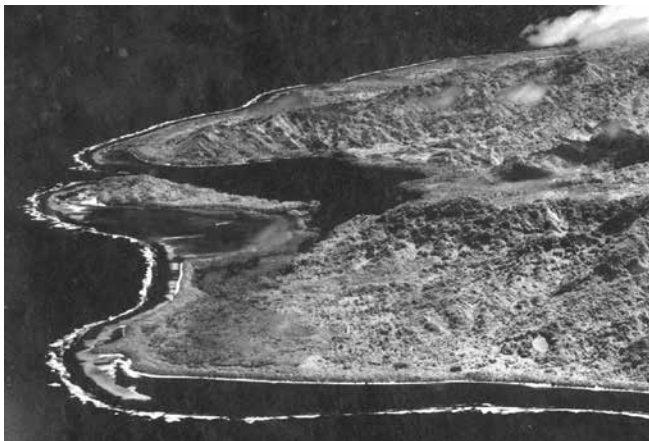
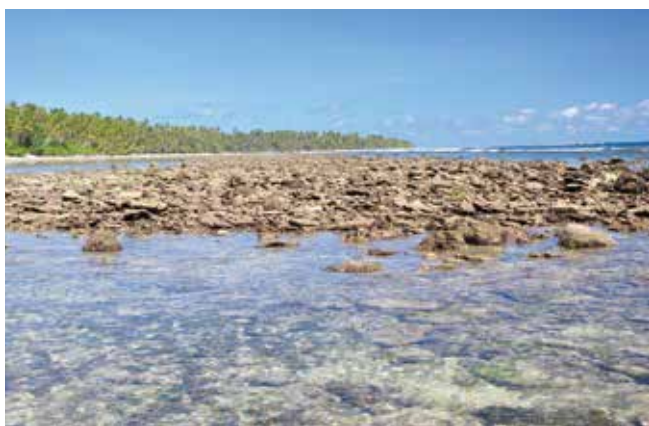
Figure B 9: Aerial photograph of the north-east Kosrae coast in 1944 (top) and the remnants of the rubble ridge in 2013 at Putukte (bottom). The rubble ridge extending from Finaunpes all the way down the Pukusruk shoreline to Putukte can be clearly seen in 1944. The size of the ridge between Finaunpes and Finfokoa resulted in a build out of the shoreline in a bulge in the lee of the ridge. With the breakdown/removal of the rubble ridge, the sediment in this bulge in the shoreline has been redistributed along the adjacent coastline (see shoreline position comparisons in the section below).

these banks. The removal of such a large amount of rubble from the banks both accelerated the breakdown and shoreward migration of the remaining coral rubble but also substantially reduced the protection provided to the shoreline. The increase in wave energy reaching the shoreline has subsequently resulted in a loss of the fringing mangroves along the Malem coastline and long-term and on-going readjustment of the shoreline along much of the eastern coastline with much higher rates of erosion than has been occurring on any of the other shorelines around Kosrae.

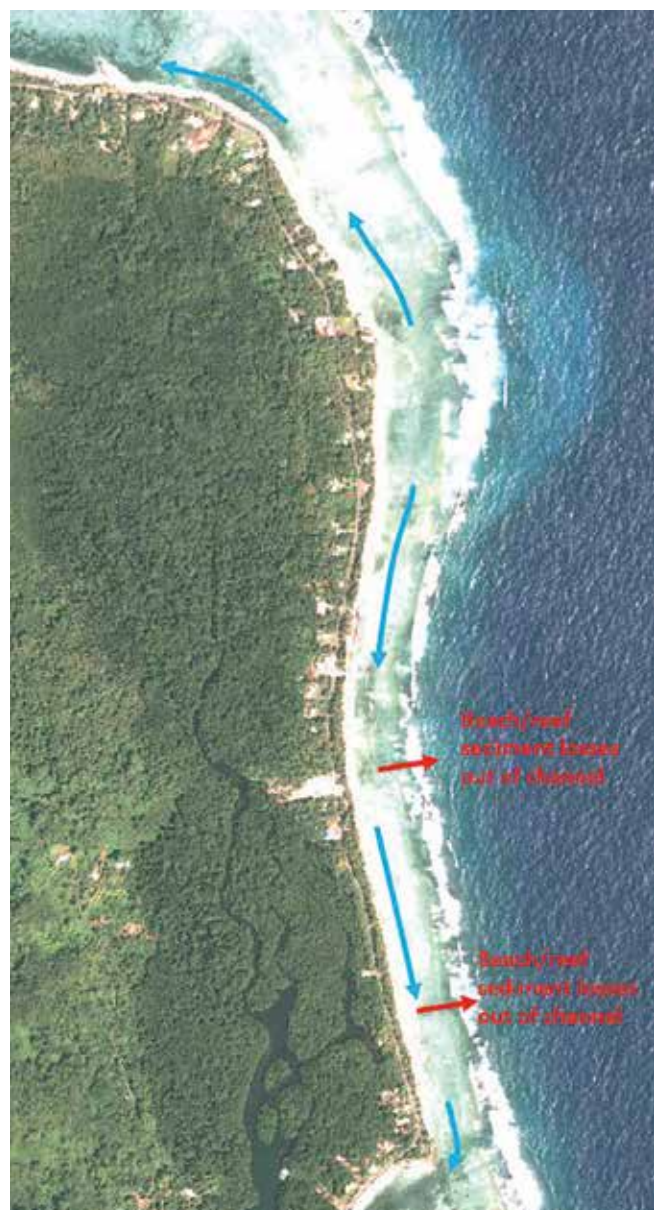
Figure B 10: Key sediment sources, longshore transport processes, and sediment losses along the Pukusruk shoreline.

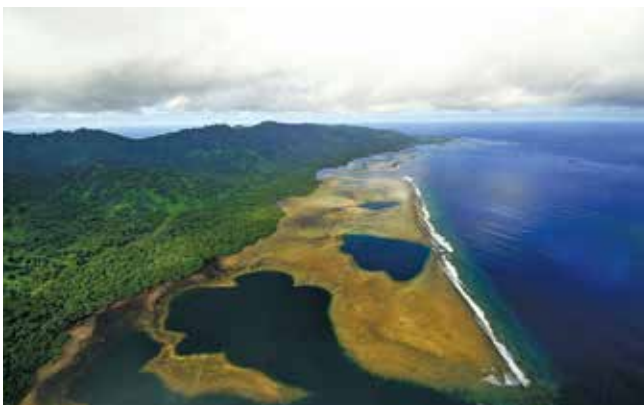
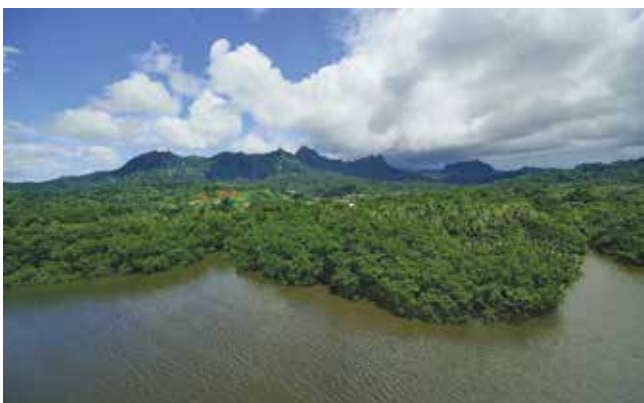
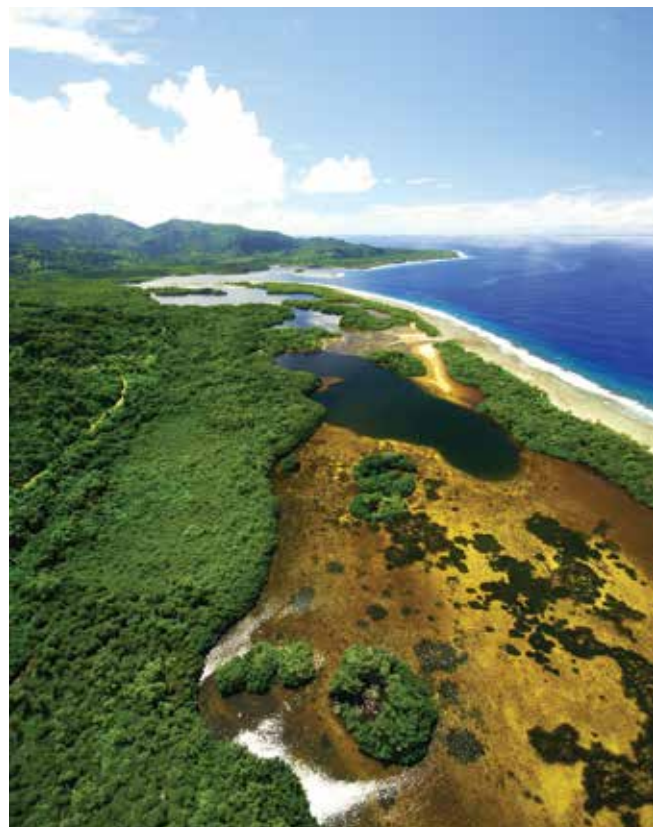
Figure B 12: Key mangrove settings on Kosrae. Top left: reef flat mangroves between Okat and Yela; Bottom left: Fringing harbour mangroves in Lelu Harbour at Tofol; Right: Back lagoon mangroves between Nefalil and Utwe Ma.

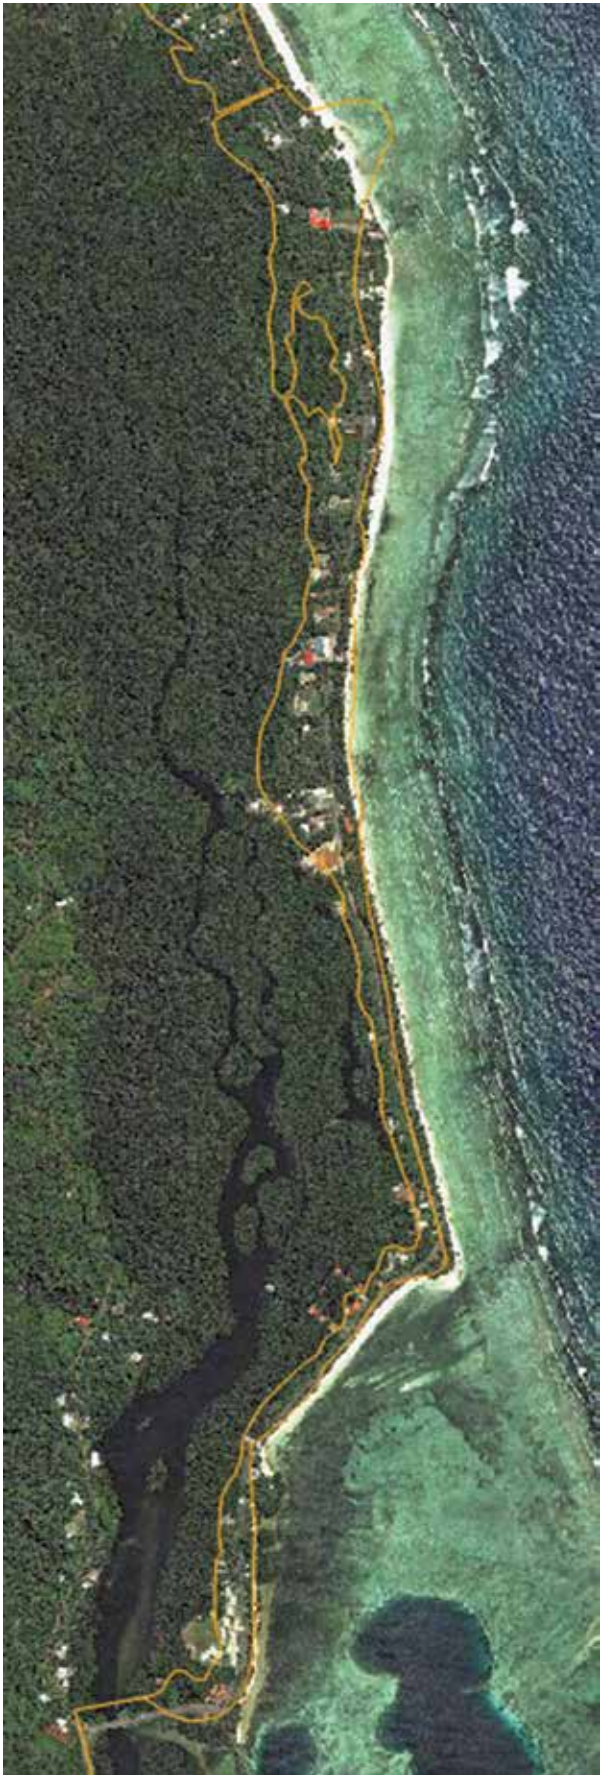
Lelu: Finfokoa to Finpukal

- The image on the left shows the rectified 1944 aerial image with the digitised 2012 shoreline (red line). Where:
  - The red line is seaward of the shoreline shown in the 1944 aerial image, the coastline has built out (accreted) between 1944 and 2012.
  - The red line is landward of the shoreline shown in the 1944 aerial image, the coastline has eroded between 1944 and 2012.
- The right hand image shows the 2012 satellite image with the 1944 digitised shoreline (orange line). Where:
  - The orange line is seaward of the shoreline shown in the 2012 satellite image, the coastline has eroded between 1944 and 2012.
  - The orange line is landward of the shoreline shown in the 2012 satellite image, the coastline has built out (accreted) between 1944 and 2012.

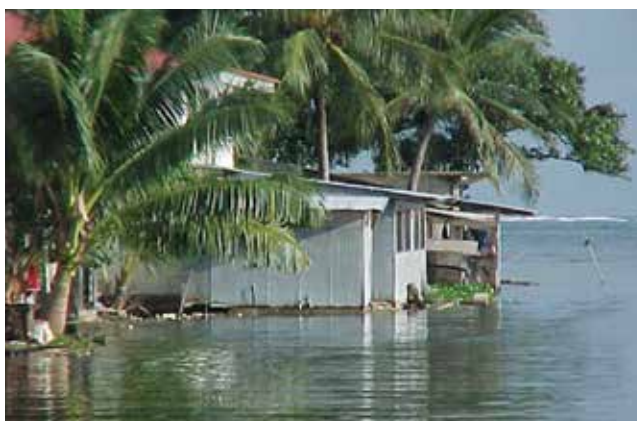
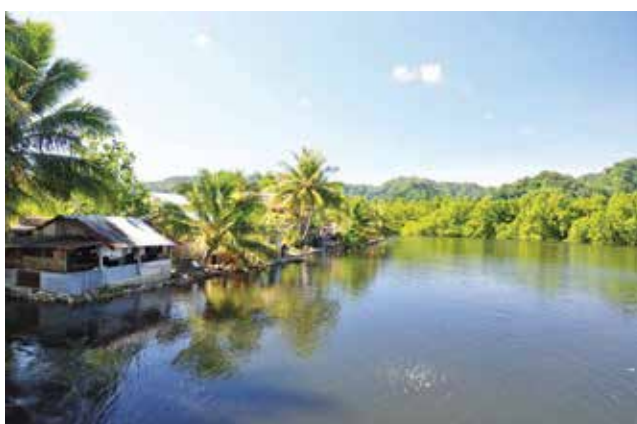
Figure C 1: High tide levels at Lelu during December 1999 (left) and Utwe during December 2010 (right).

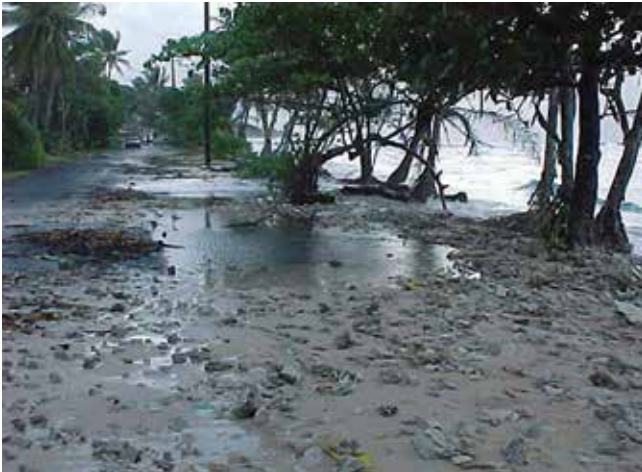
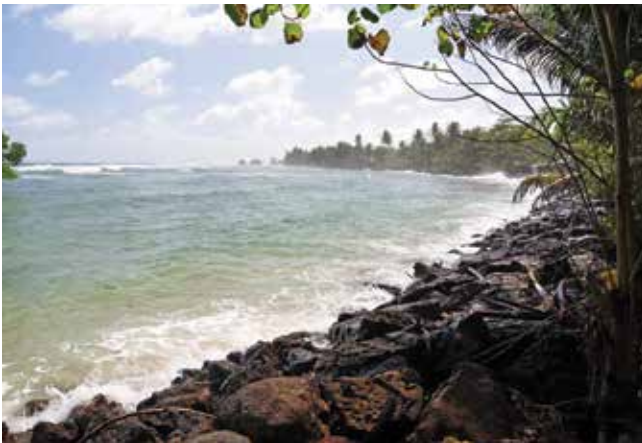
Figure C 2: Wave overwashing at Fukrin in Malem during February 2000 (left) and high tide wave overtopping of the seawall at Malem village during December 2010).

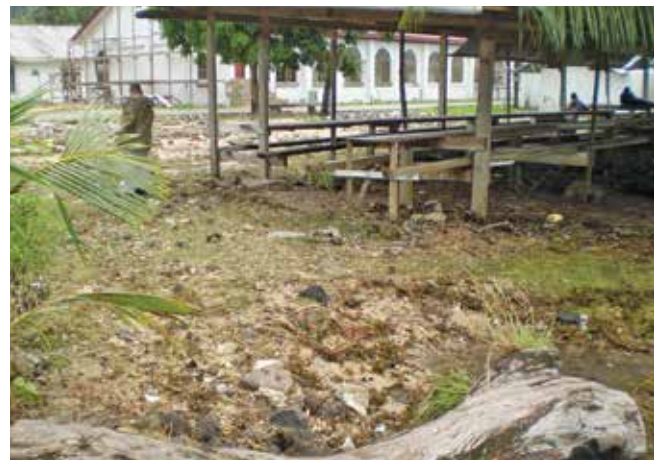
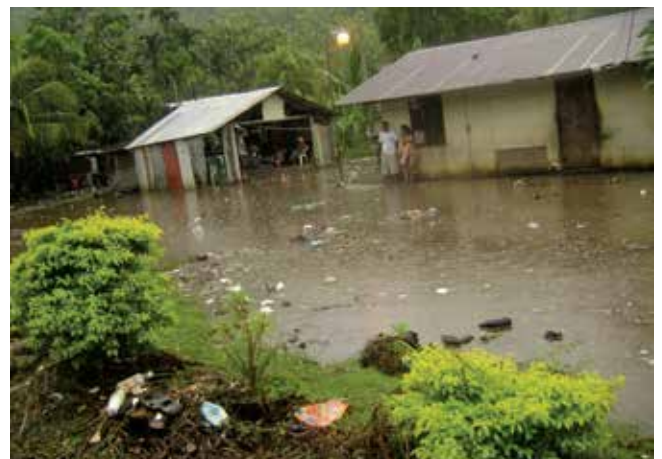
Figure C 3: Debris from overwashing of the seawall at Tafunsak (left) and at Malsu (right) during the swell event of 8-9 December 2008.

The coastal flooding that affected the northern coastline (Tafunsak, Walung and parts of the Lelu coastline) of Kosrae during the 8 and 9 of December 2008 (Figure C 3) was due to large swell waves generated by a severe storm far to the north of Kosrae. The inundation extent along the Tafunsak coastline is shown in Figure C 4 which shows some particular characteristics:

- The seawall at Tafunsak did not provide any greater protection to the land behind from overwashing waves than the beach sections of coast.
- The extent of inundation was worst over the low-lying land adjacent to the stream outlets at Yekula, Malsu (Senny's Store) and at the old outlet of Infal Mutunte in Tafunsak village).
- Inundation extent was least where there was a largely natural vegetated buffer behind the beach (e.g., between Finaunpes/Inkoeya and Sialat) or seawall (such as west of the church in Tafunsak).

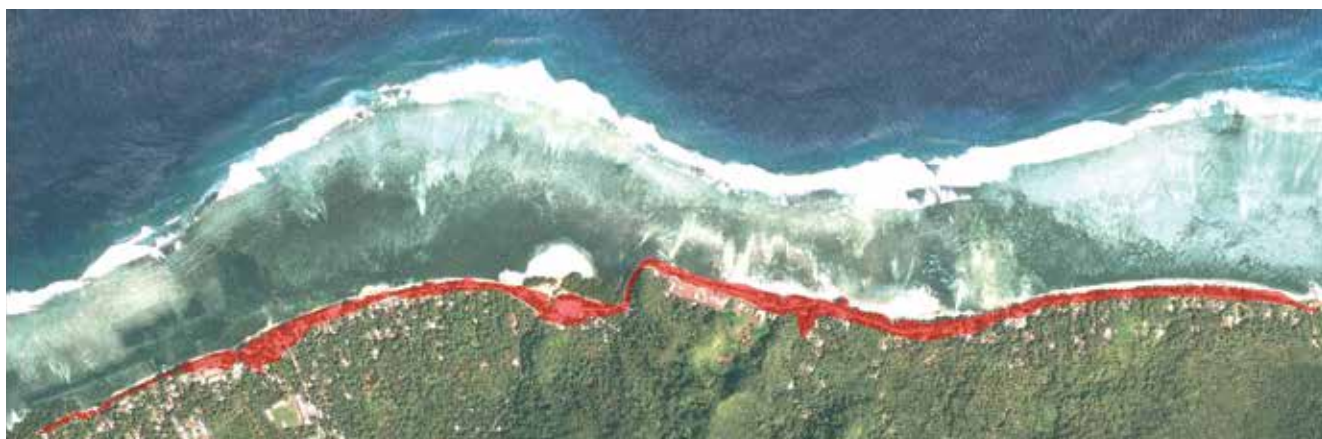
Figure C 4: Extent of inundation along the Tafunsak coastline during the swell event of 8-9 December 2008. Inundation extent information courtesy of KIRMA.
